Geological, geophysical and engineering geological investigation of a leaky Micro-dam in the Northern Ethiopia

Gebremedhin Berhane

ABSTRACT

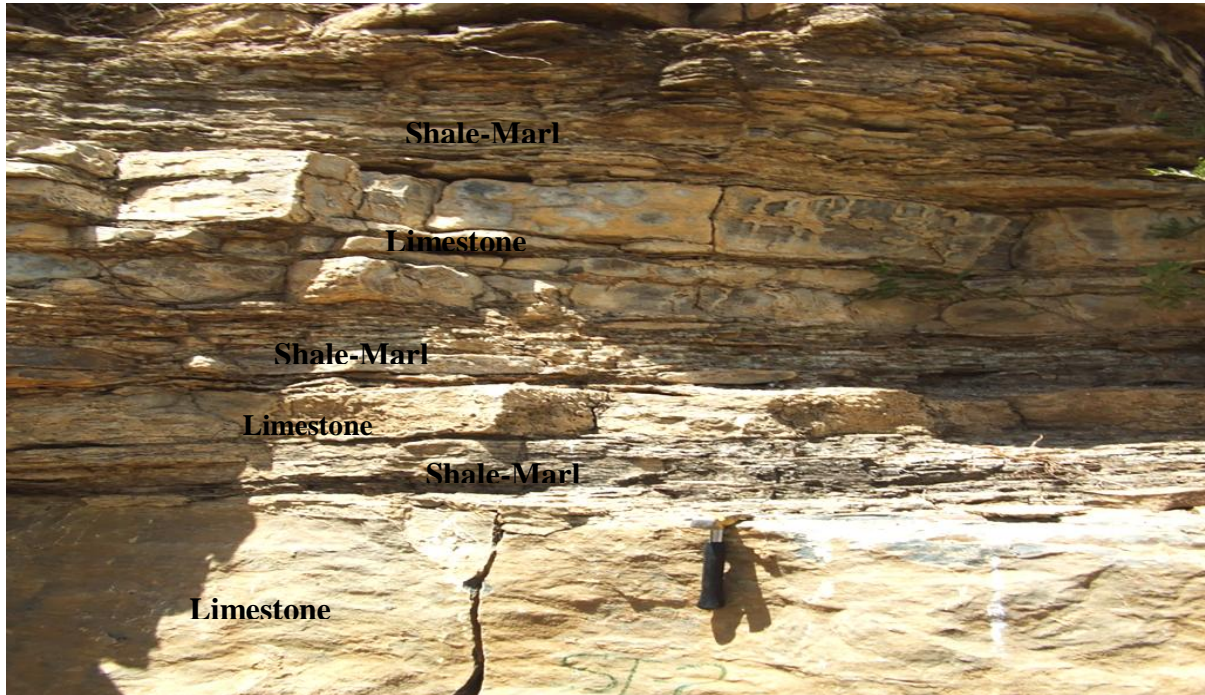
Figure 3. Limestone-shale-marl intercalation unit exposed on the left reservoir side.

It covers the left abutment and part of the reservoir area. This unit shows cyclic sequence (Fig. 3) of limestone, shale and marl beds as also revealed from VES results (Table 2). The beds are sub-horizontal to inclined at different angles. The dominant strike and dip of the inclined bed is $300^{\circ}/40\text{SW}$, but local deviations are also common, dip amount is as steep as 50° . The strike of the inclined bed is nearly parallel to the Mekele normal fault belt. Bed thickness is variable from thin laminations in shale up to one meter or more thick limestone bed.

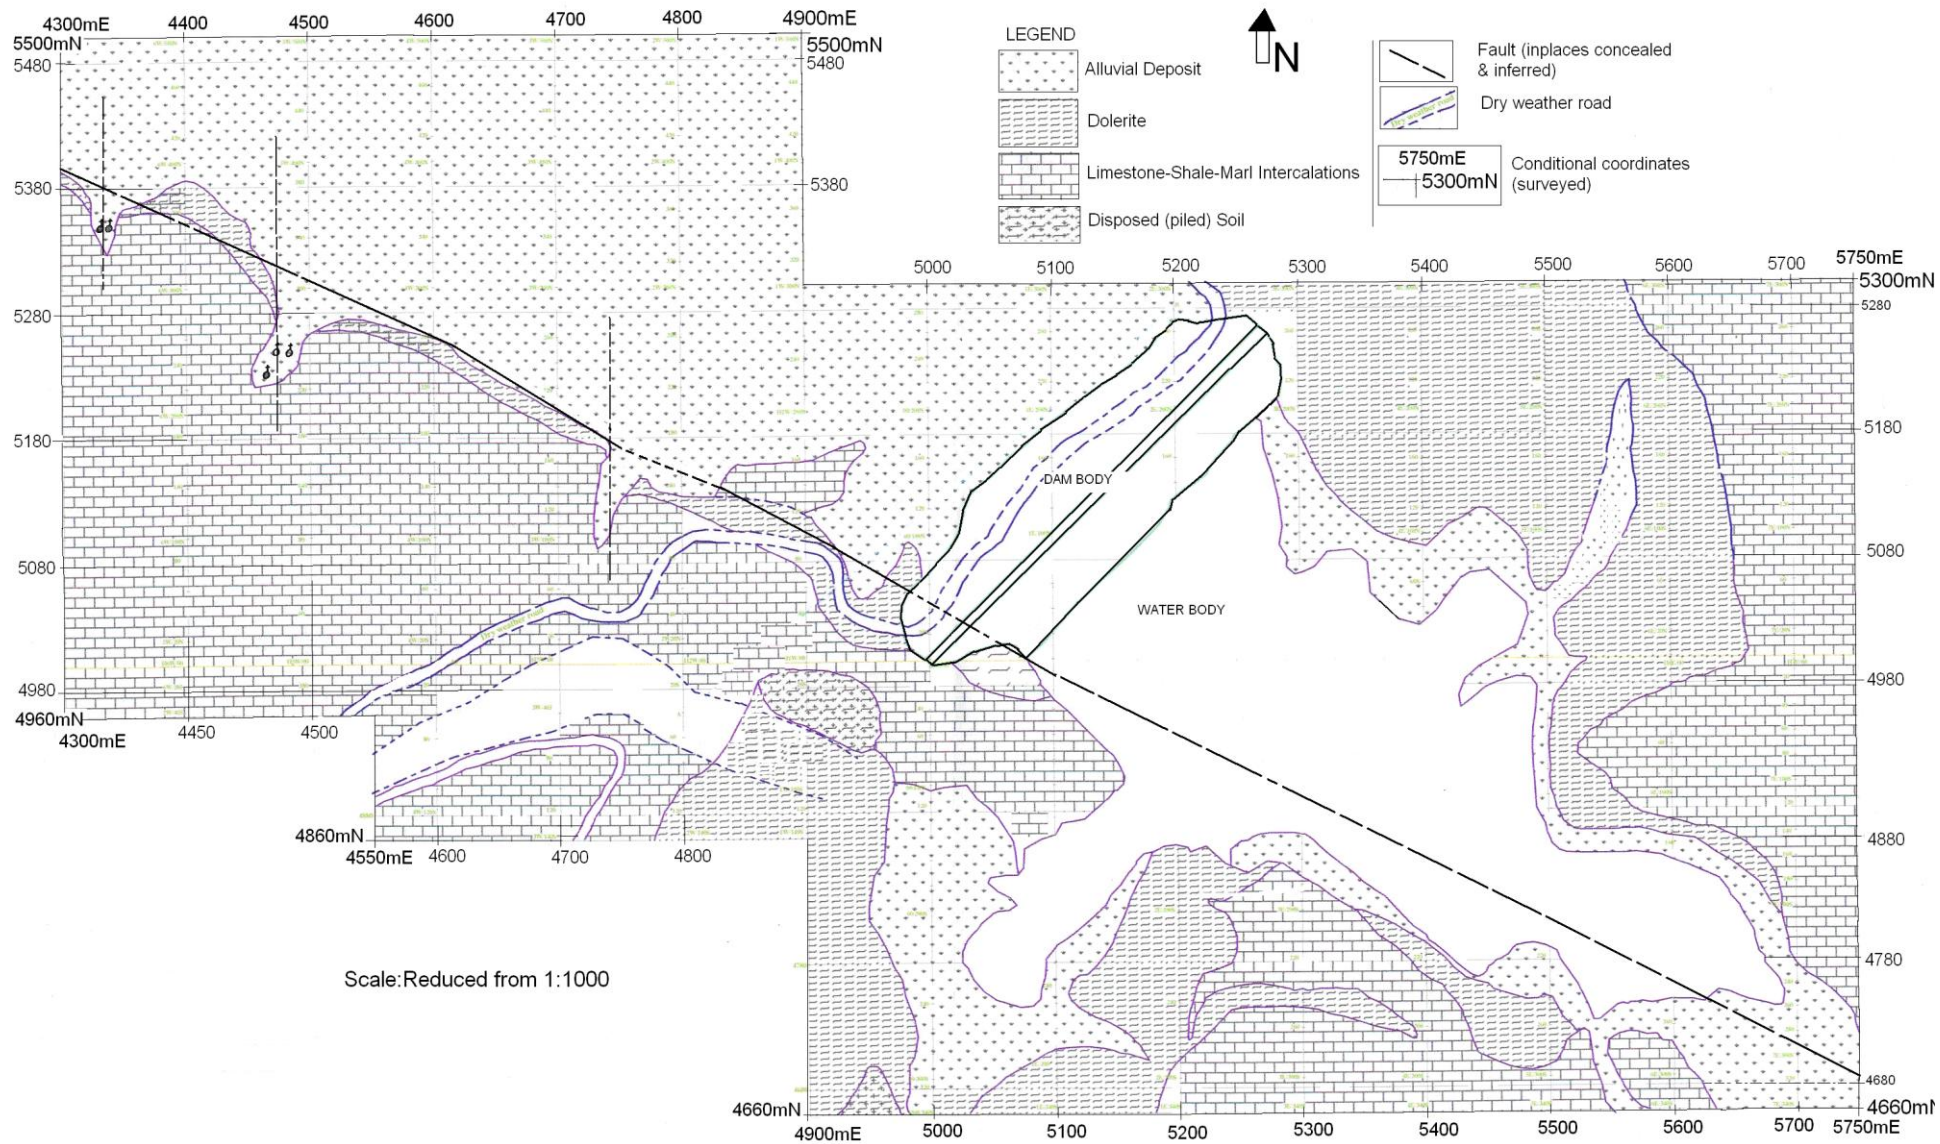
Figure 4. Geological map of Hashenge dam site and its reservoir area.

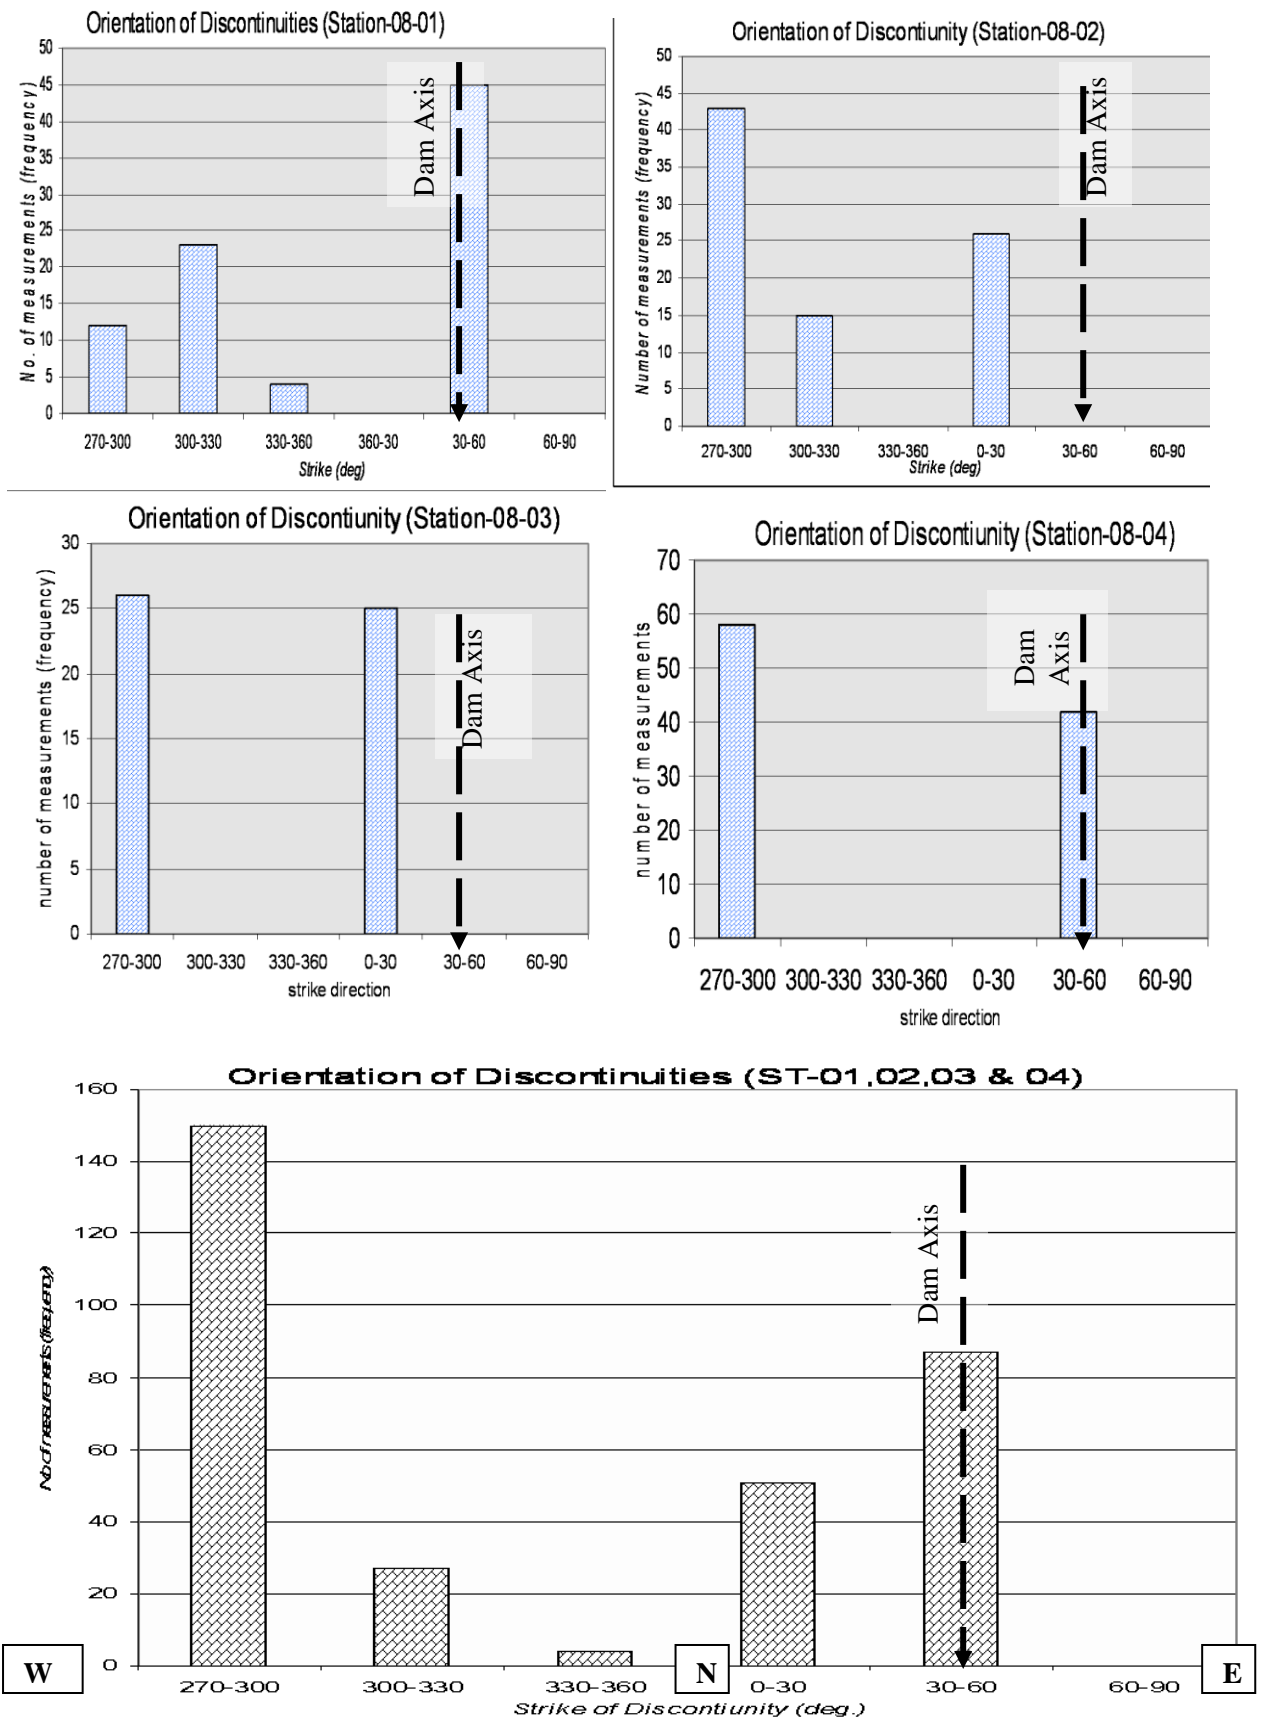
Figs.6 and 7 shows histogram of discontinuities taken on the left abutment (Table 1). Leakage of water through rock masses usually takes place via the discontinuities, although in some sedimentary rocks leakage through the pores may also play an important role. The joint parameters measurement in the field include joint spacing, opening/aperture, strike and dip, infill material type and amount, continuity and number of joints at the station or exposure extent.

Figure 6. Histogram of discontinuities (Left Abutment)

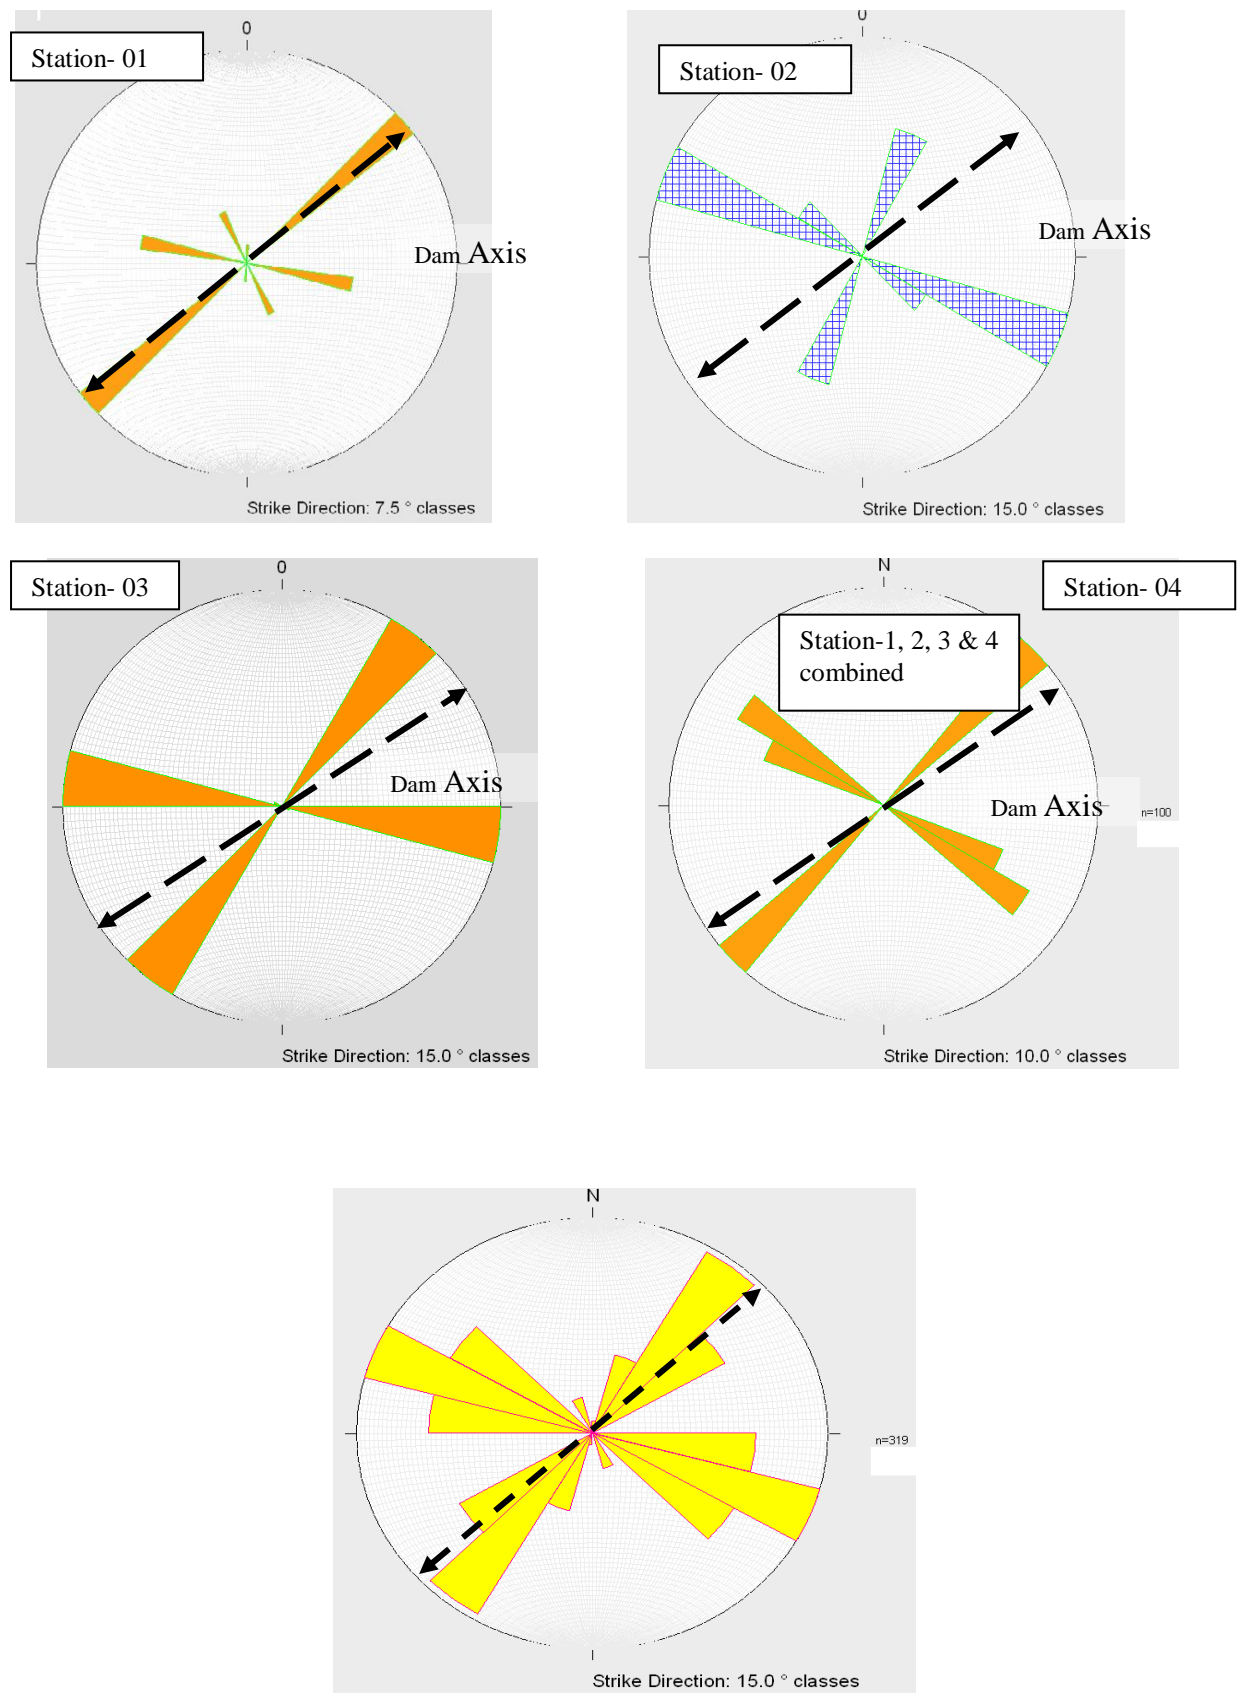
Figure 7. Stereogram of discontinuities (Left Abutment), double arrow shows dam axis orientation.

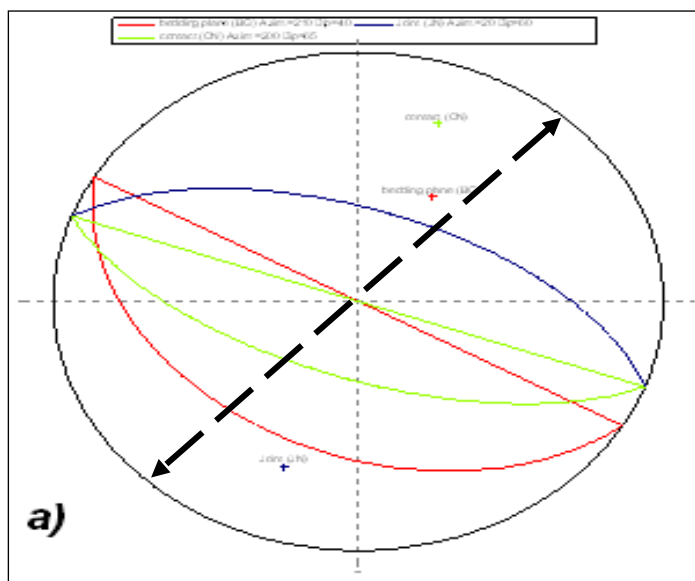
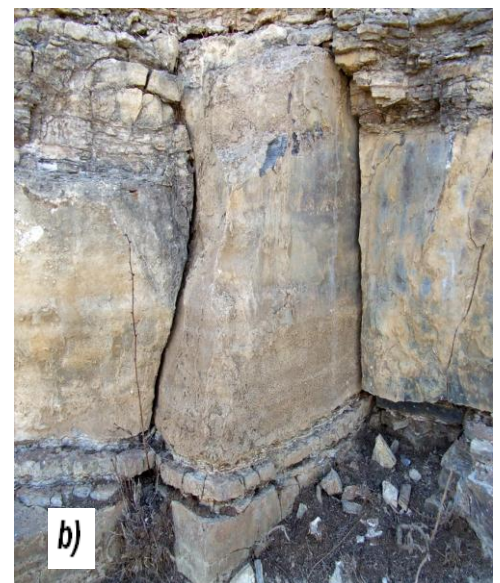
The unit is highly affected by discontinuities of different type, like bedding joint, contact, tectonic joint, etc. Two major sets of joints are dominant. The NW and NE trending discontinuities are the dominant sets and these discontinuity sets intersect at nearly constant angle forming a system. In addition to the two major sets of discontinuity there are a number of discontinuities with variable trend.

Figure 8. a) Stereographic projection of representative bedding joint, tectonic joint and contact, b) Field photograph showing bedding and tectonic joints.

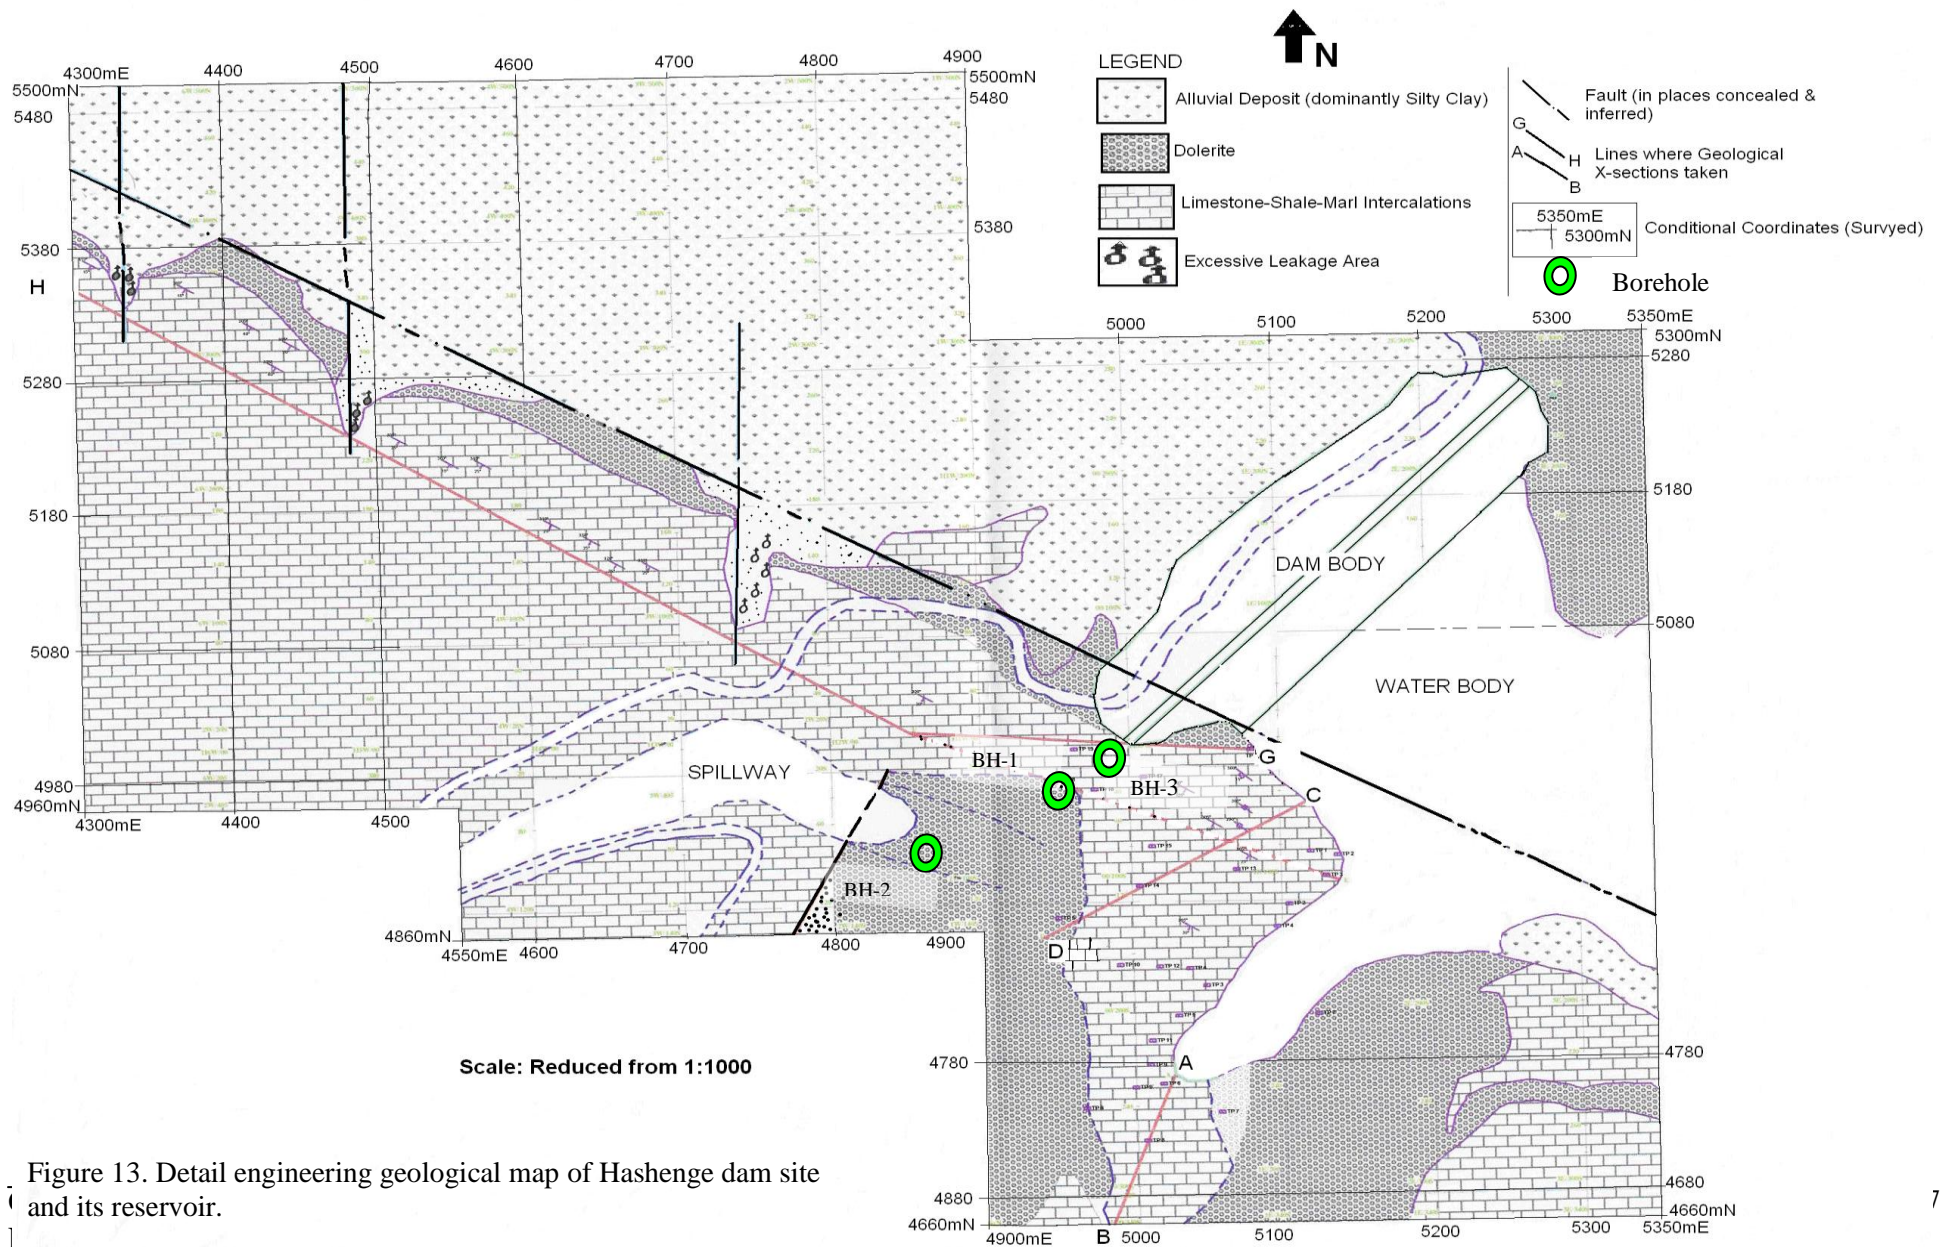
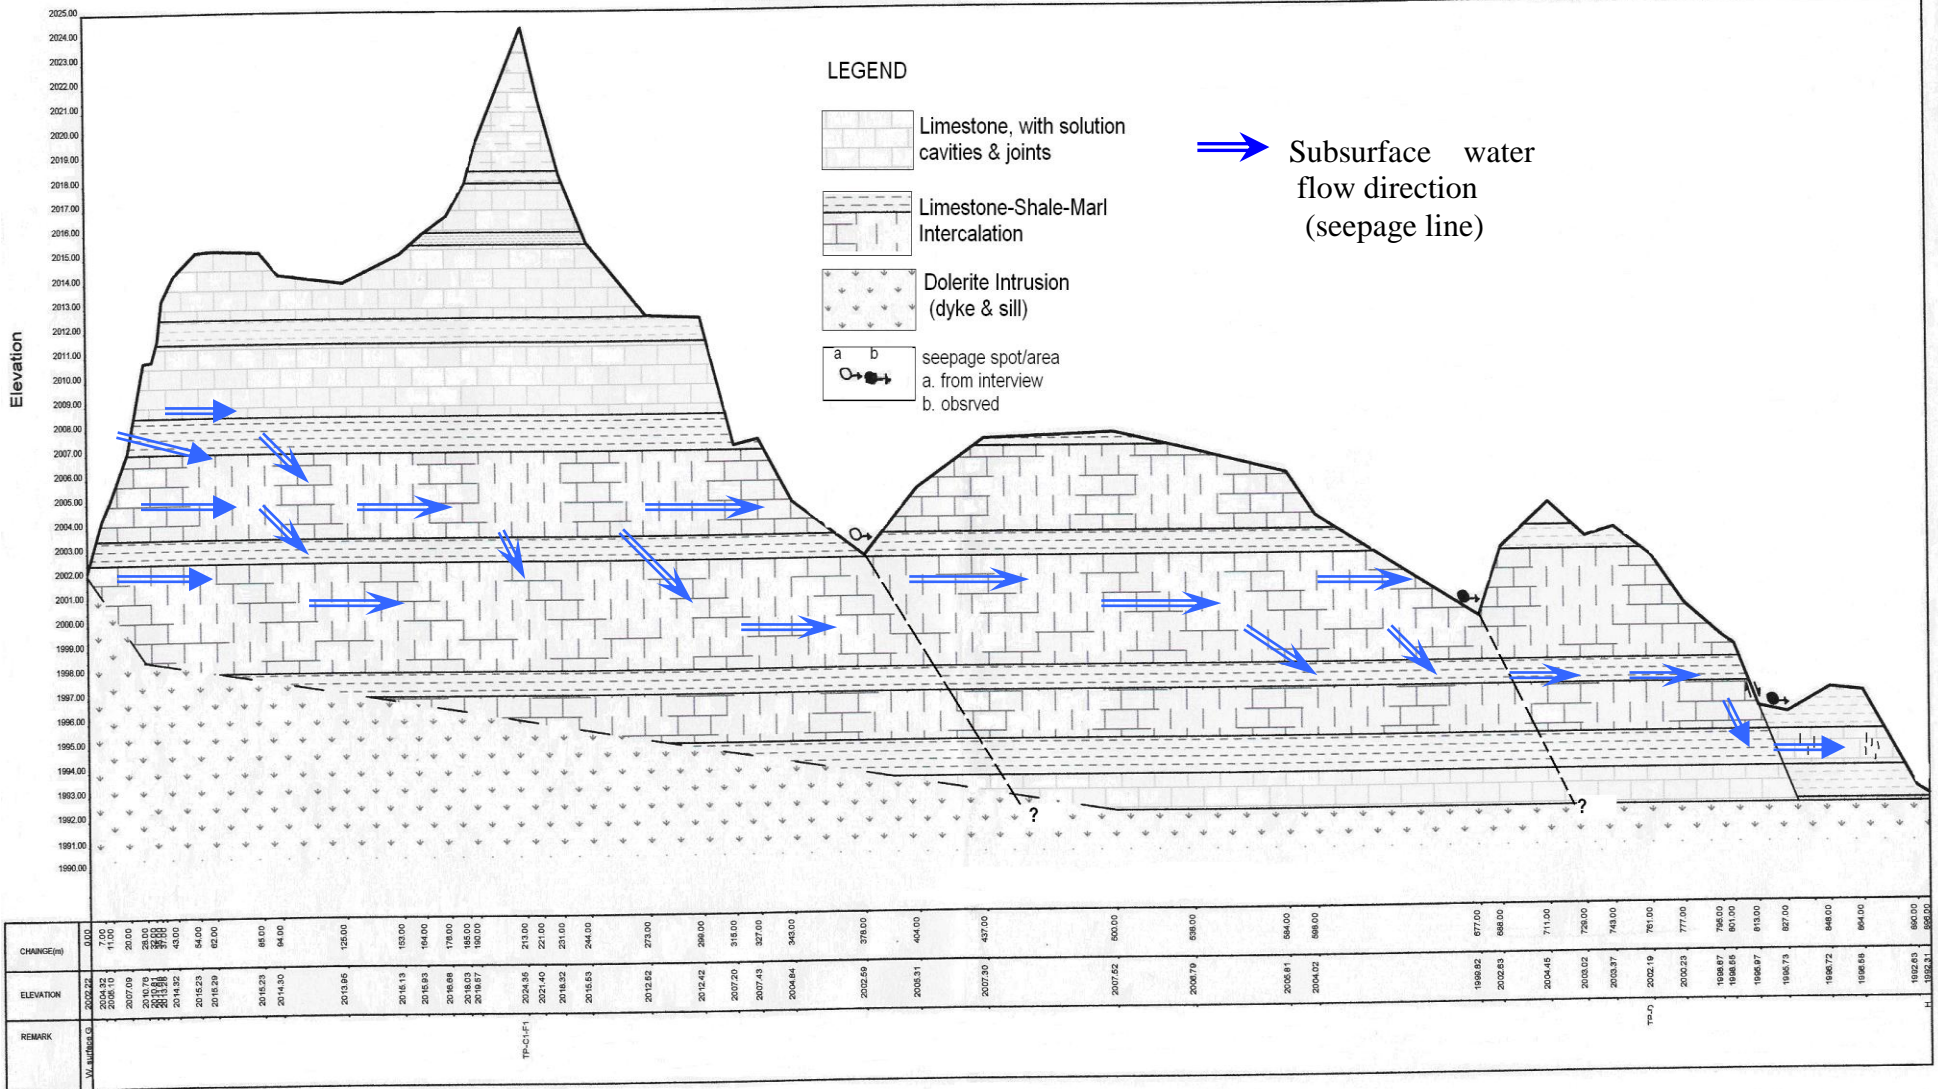
Geological cross-Section along GH

Figure 14. Engineering geological cross-section (Upstream to down stream side along the left abutment (Arrows show flow direction/leakage)

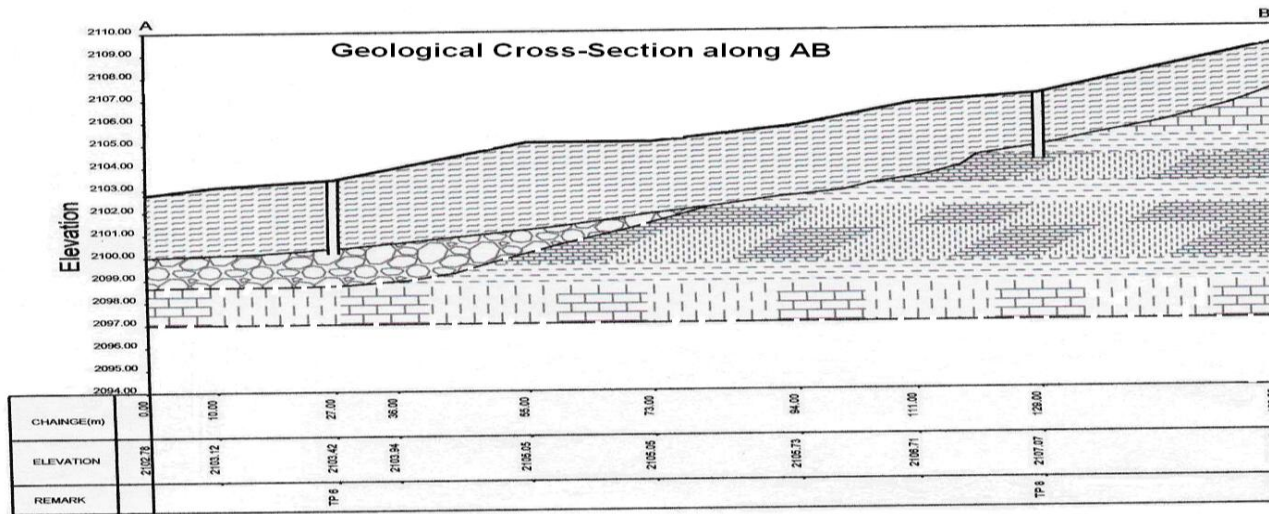
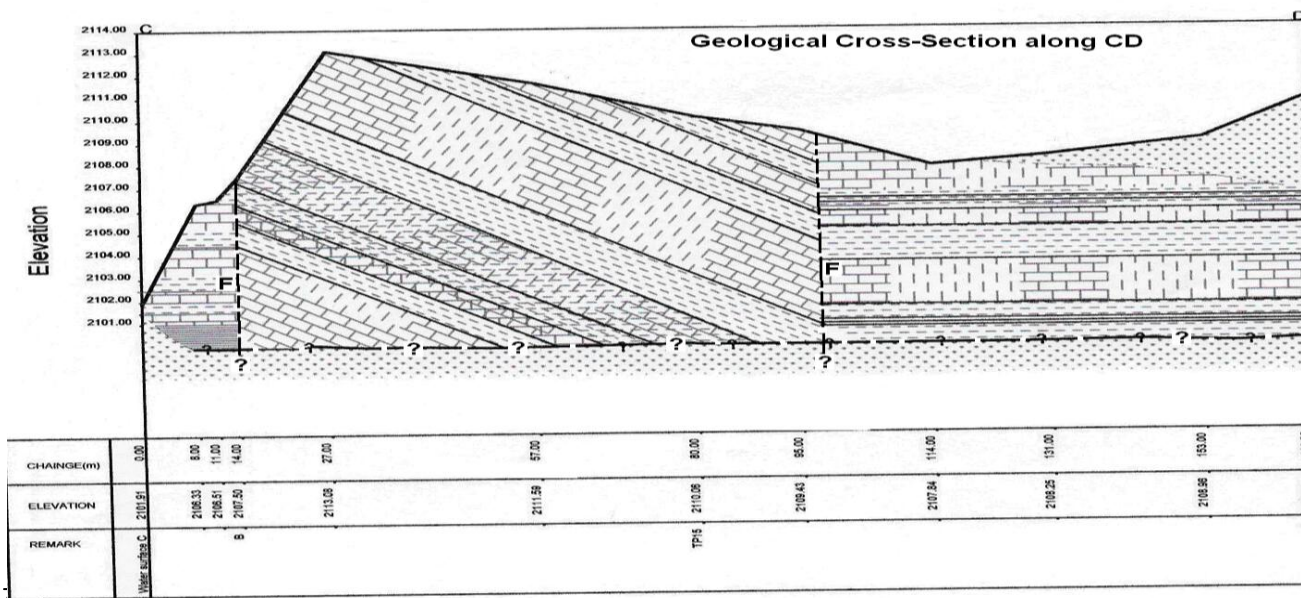
Engineering International: the CIGR Ejournal. Manuscript No. 1346, Vol. XII, March, 2010.
 Figure 15. Engineering geological cross-section along AB and CD

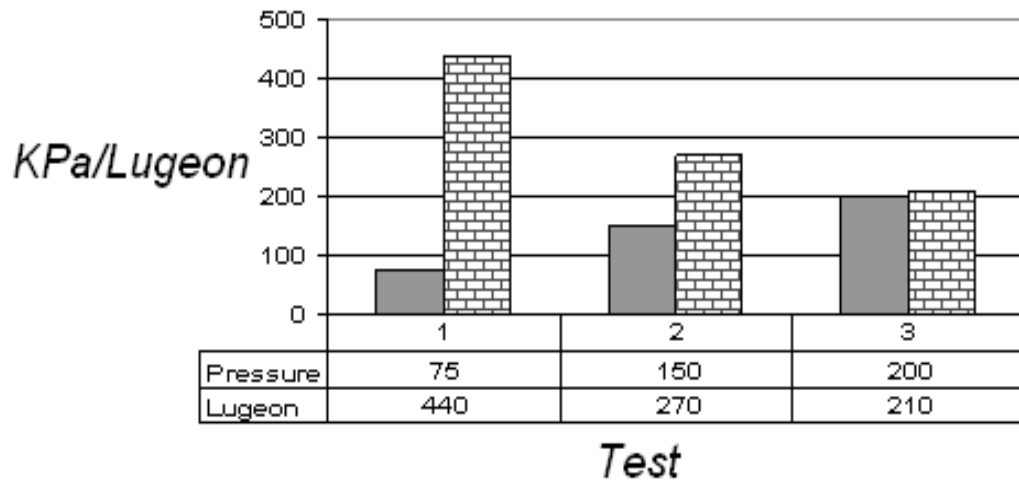
The test was conducted in three stages at different pressures. Calculation of the permeability of the rock mass shows in the order of 10^{-3} cm/sec. A bar chart (Fig.16) showing the relationship of test pressure and Lugeon indicates a continuous reduction in Lugeon value as test pressure increases. This condition is related to filling of void or fractures by finer materials during the course of testing.

Figure 16. Bar chart showing relationship of test pressure and Lugeon value.

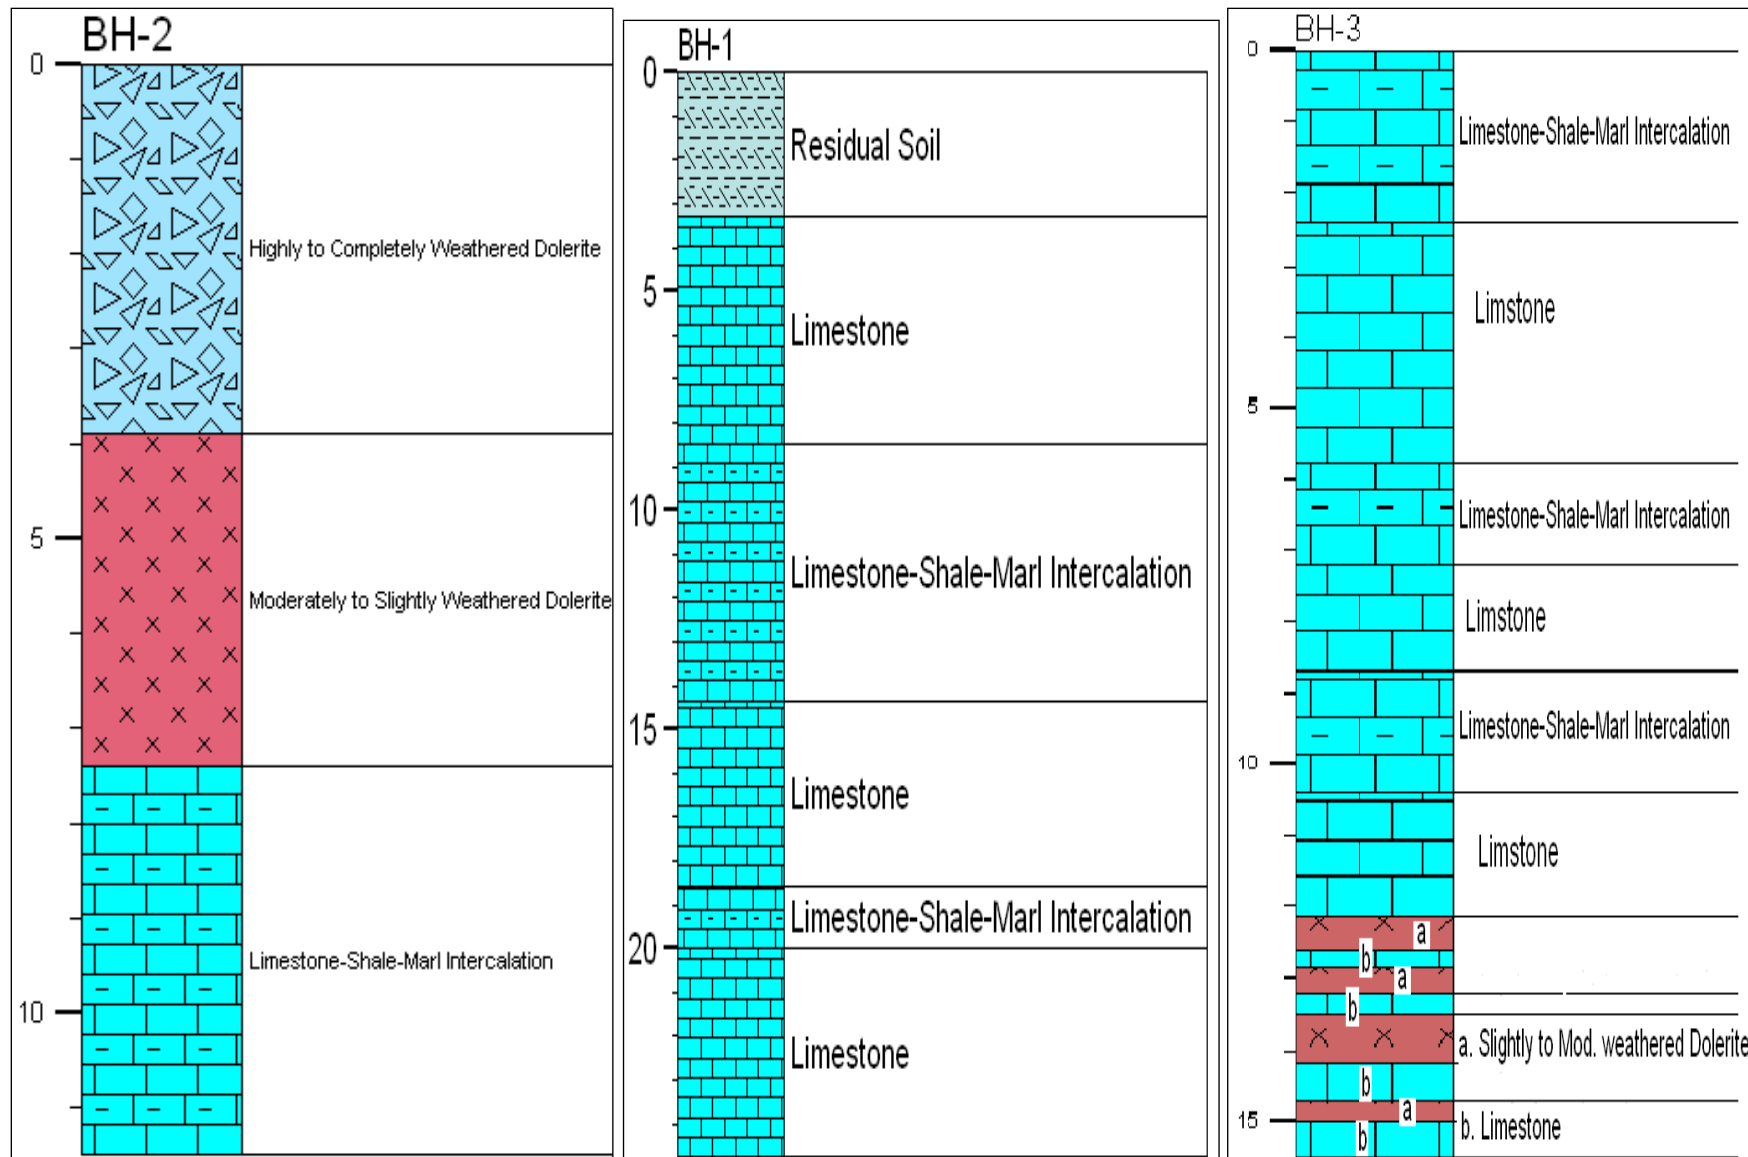
Figure 17 shows log of the three boreholes drilled on the left abutment and spillway route of the dam. A close inspection of the core samples indicates variation in lithology, weathering grade, fracturing and thickness of beds with depth and space. The drilling operation and samples recovered further confirmed the presence of high permeable layers or beds, perhaps cavities.

Three of the boreholes show almost similar geological units with variation in fracturing and weathering. The main units include limestone, shale and marl, but at BH-2 and 3 a dolerite unit is also encountered. Their thickness is variable and generally it occurs in a cyclic fashion or sequence. At BH-2 dolerite extends to a depth of 7.4m, below this depth a sedimentary sequence of shale and limestone are the dominant units. Similarly at BH-3 trace of dolerite sill start at a depth of 12.11m and continues at a depths of 12.84, 13.95, 14.10 and 14.7m. From these drill holes it is clear that limestone is the dominant rock unit and governing factor with respect to the hydraulic conductivity of the rock mass.

Figure 17. Simplified lithological log of the three boreholes

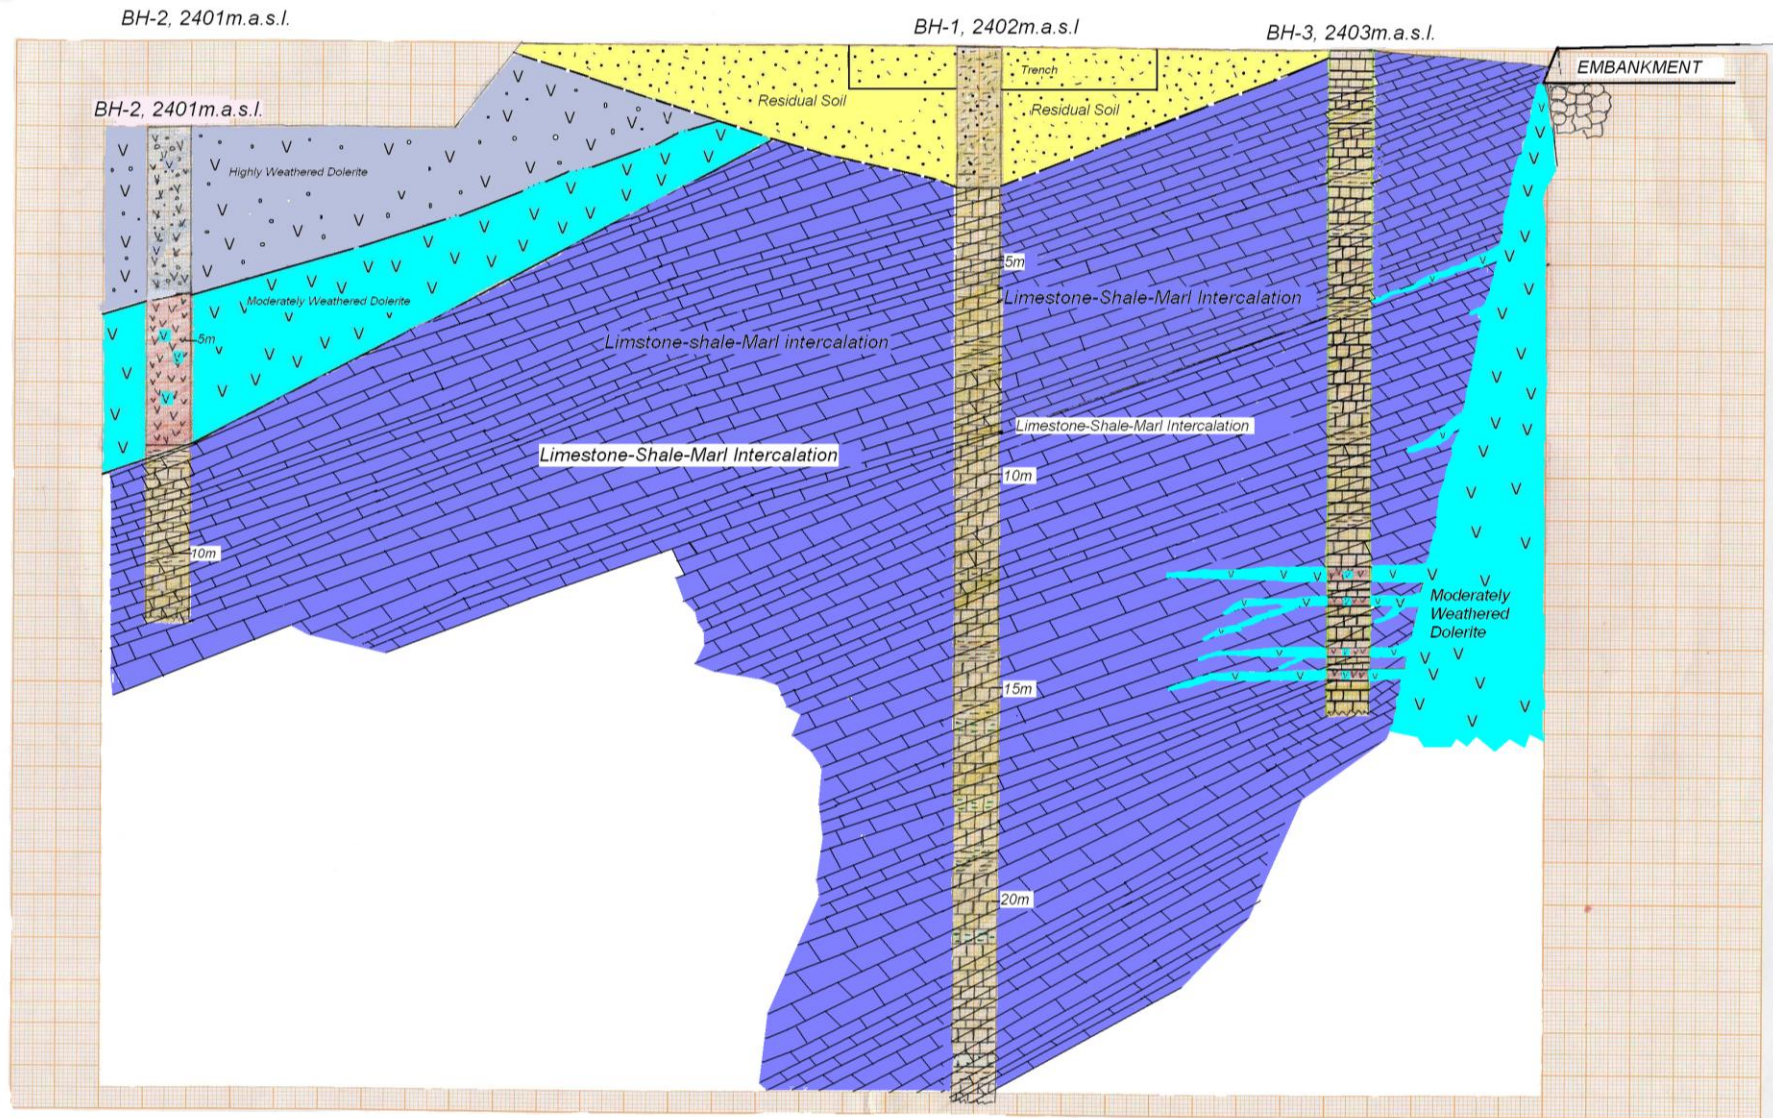
Synthesis of the different surface and subsurface information collected during the course of this research work lead to develop a comprehensive geological cross-section or model (Fig. 18). The model helps to understand the leakage phenomena and assist in proposing and implementation of mitigation measures.

Figure 18. Engineering geological cross-section along the three boreholes (model)
