# Geological, geophysical and engineering geological investigation of a leaky micro-dam in the Northern Ethiopia

Gebremedhin Berhane

**Abstract:** The study was conducted to assess the main causes of leakage problem in the Hashenge micro-dam, located in the Tigray regional state, northern part of Ethiopia. The micro, dam is a 19 m height earth fill dam with the length of 387 m and reservoir capacity of about 2.3 million cubic meters at maximum water level. Geological, geophysical and engineering geological investigations were conducted in the abutment and reservoir area to assess and pinpoint the main causes. The dominant lithologic units include limestone-shale-marl intercalation, dolerite and recent soil deposits. Vertical electrical sounding was used to locate geotechnical boreholes and to know vertical and lateral variability of geological materials. Geotechnical and engineering geological investigation including drilling of three boreholes and packer testing along with detail measurement and analysis of discontinuity parameters was conducted. Analysis of the data showed that the sedimentary succession, limestone-shale-marl intercalation was the leaky unit and responsible to

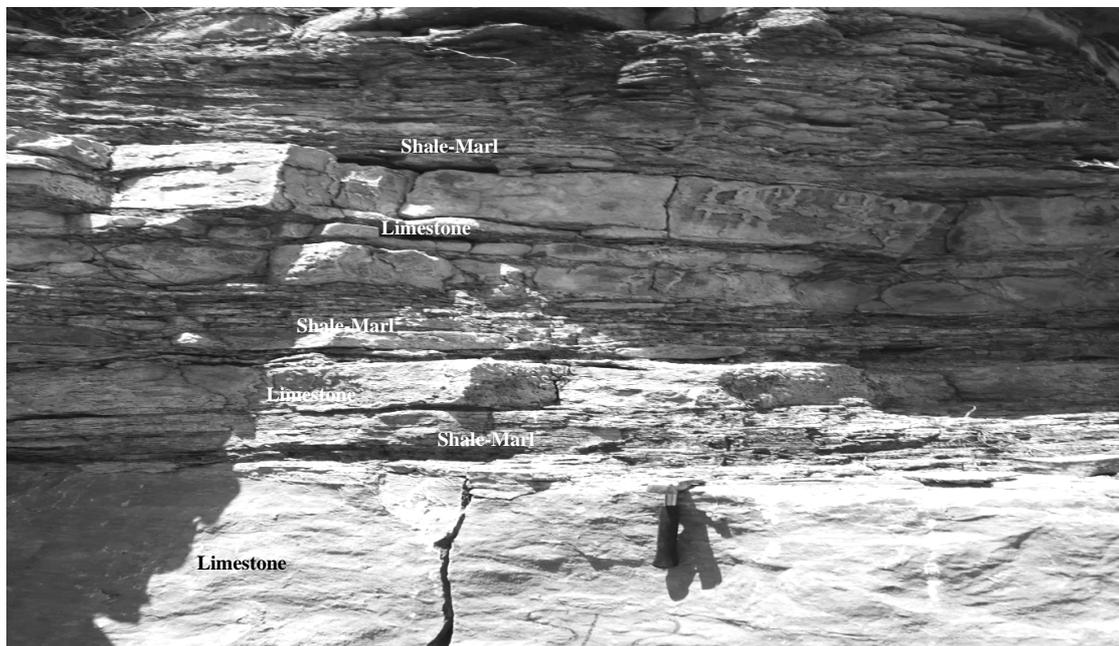
The sedimentary unit limestone-shale-marl intercalation (Figure 4) covers large portion of the area. Its color varies from place to place and with depth (white, yellowish, brown, etc).

The beds are mostly horizontal, but in places they are inclined mainly due to intrusions and faults. All grades of weathering are observed in these rock units. Near contacts to the dolerite the shale-limestone-marl intercalations are highly disintegrated due to baking effect of dolerite intrusions. Layer of shale within this intercalation is fissile, weak, highly to completely weathered, while the marl and limestone are relatively

Figure 4 Limestone-shale-marl intercalation unit exposed on the left reservoir side

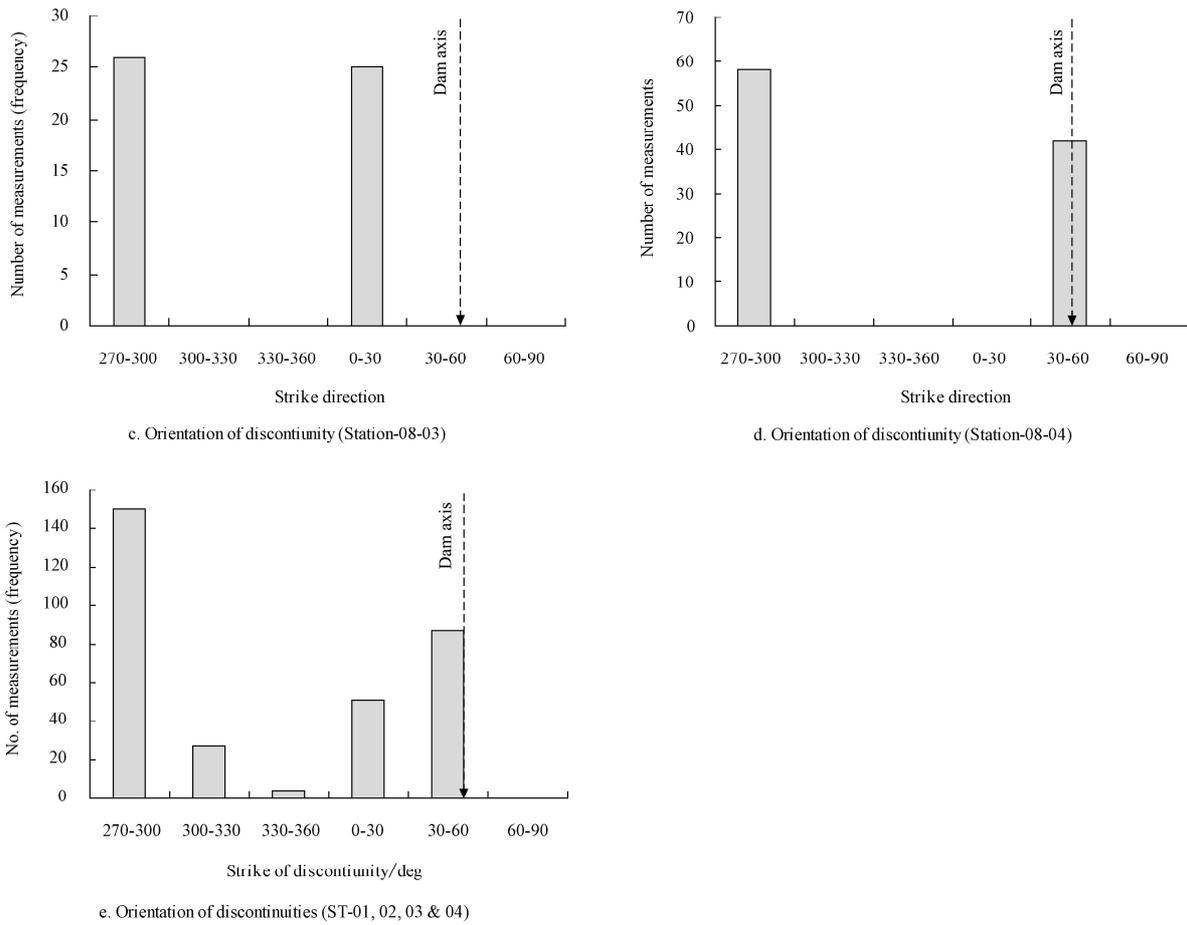
Figure 6 and 7 show histogram of discontinuities taken on the left abutment (Table 1). Leakage of water through rock masses usually takes place via the discontinuities, although in some sedimentary rocks leakage through the pores may also play an important role. The joint parameters measurement in the field include joint spacing, opening/aperture, strike and dip, infill material type and amount, continuity and number of joints at the station or exposure extent.

Figure 6 Histogram of discontinuities (left abutment)

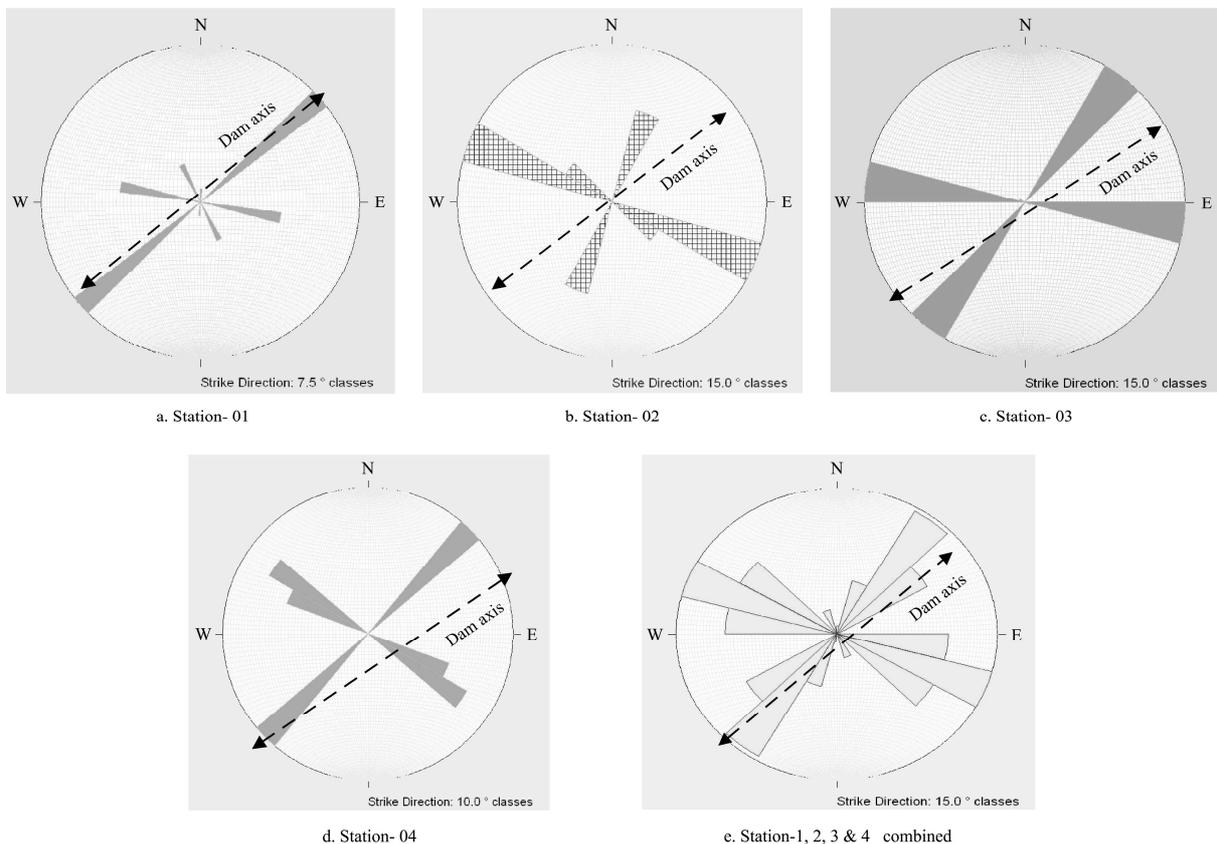
Figure 7 Stereogram of discontinuities (left abutment), double arrow shows dam axis orientation

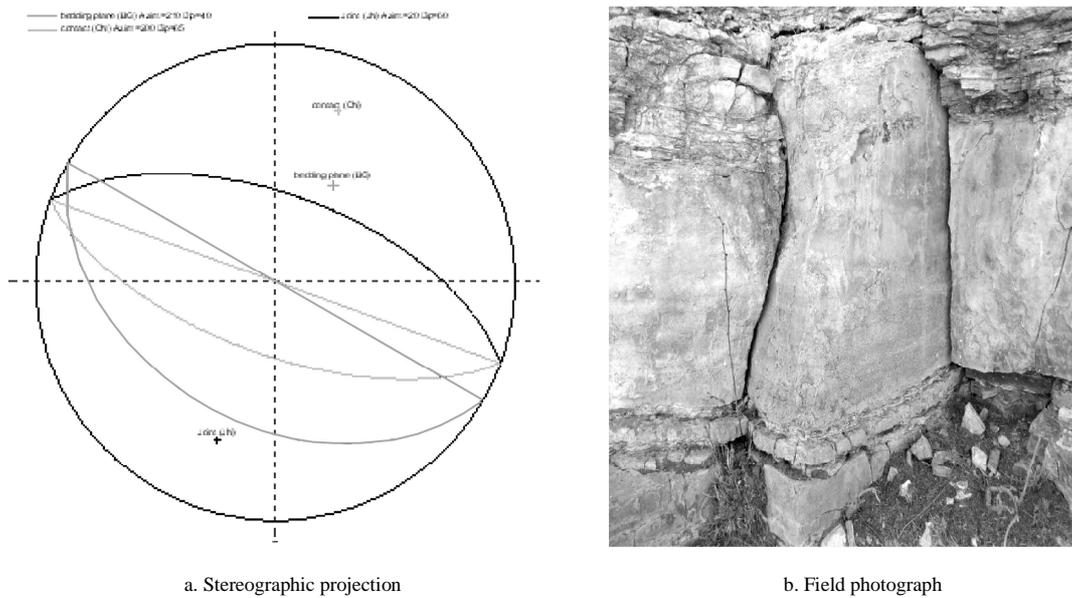
The frequency or spacing of joints (Figure 8) on average ranges from 30 to 45 per meter, i.e. closely to very closely spaced. The joints are generally continuous laterally and in depth surface of joints (wall surface) is smooth with some calcite precipitation. The space between joint surfaces (separation/aperture) is variable from place to place (narrow to wide aperture); many of the measurements show in the order of millimeter to few centimeter.

Figure 8 Bedding and tectonic joints

Permeability of jointed rocks depends on the dimensions and nature of the joints, the closer the spacing and the wider the opening, the higher the permeability is. Joints cause planes of weakness in the rocks and form leakage channels and permit upward pressures below a dam. Joints and other discontinuities are responsible for most of the unsound and permeable rock encountered at the dam abutment and reservoir area. The mass permeability using discontinuity data is estimated in the range of  $10^{-1}$  to  $10^{-3}$  centimeter/second.

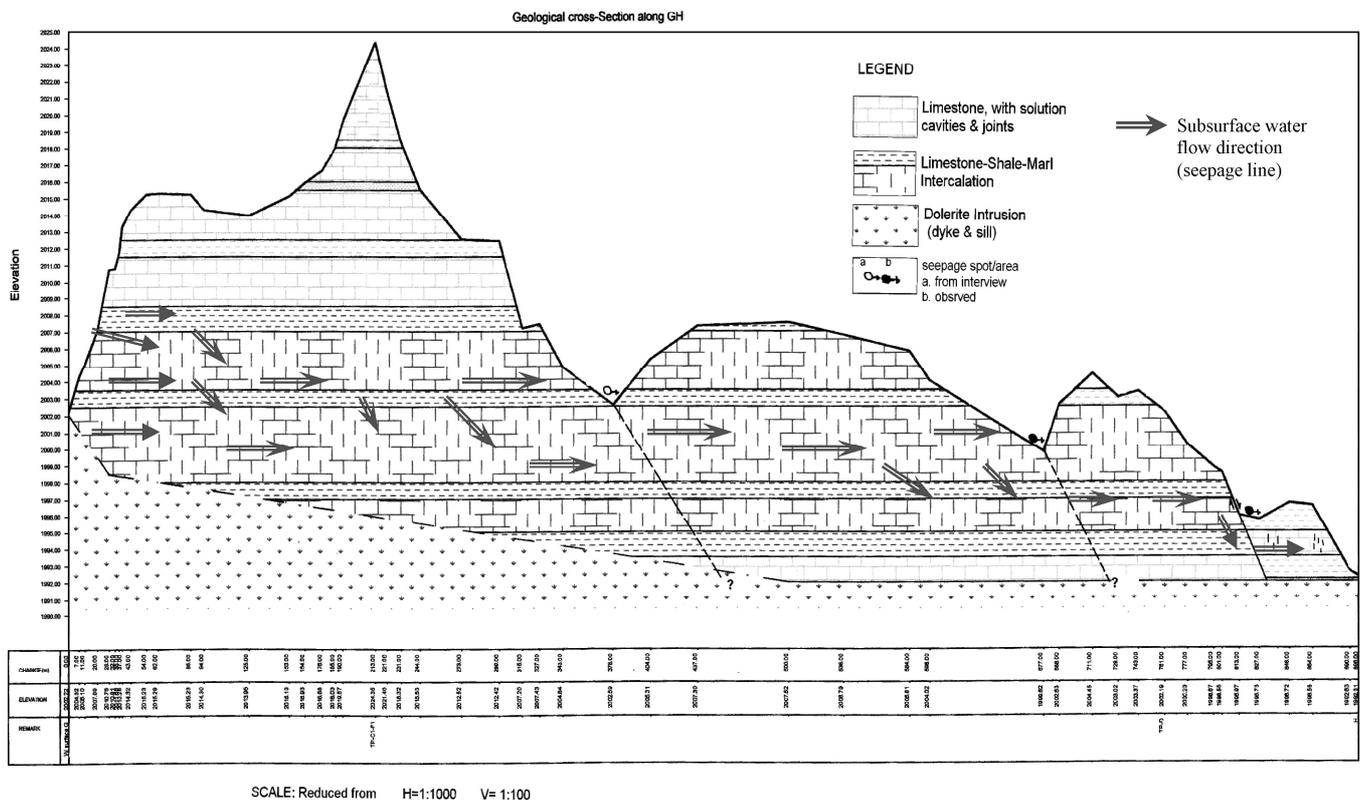
Figure 14 Engineering geological cross-section (Upstream to down stream side along the left abutment (Arrows show flow direction/leakage))

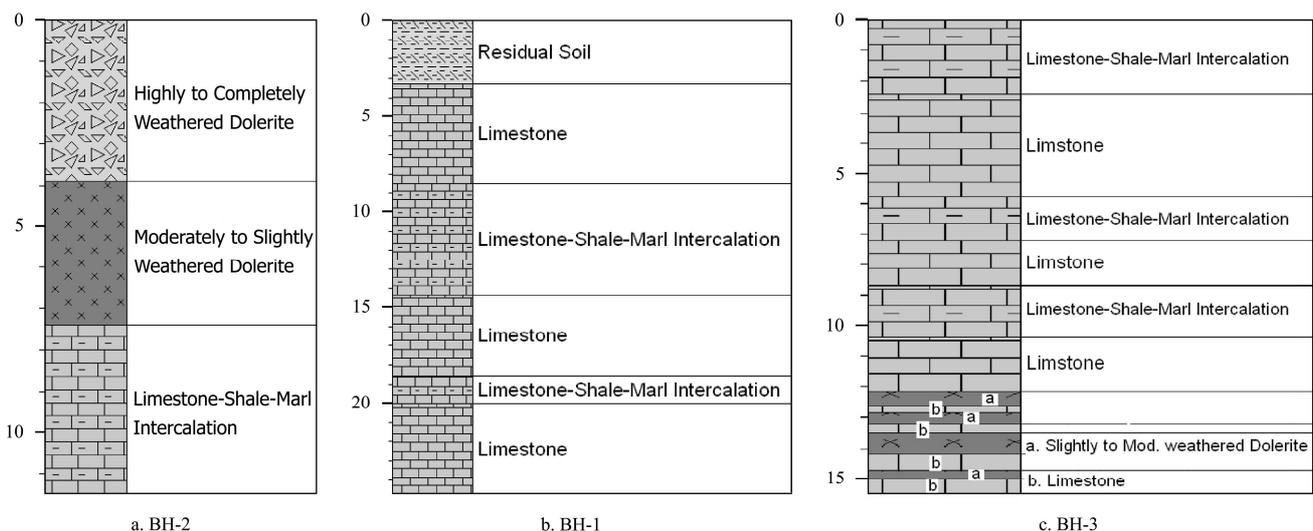
Figure 16 shows log of the three boreholes drilled on the left abutment and spillway route of the dam. A close inspection of the core samples indicates variation in lithology, weathering grade, fracturing and thickness of beds with depth and space. The drilling operation and samples recovered further confirmed the presence of high permeable layers or beds, perhaps cavities.

Figure 16 Simplified lithological log of the three boreholes

Three of the boreholes show almost similar geological units with variation in fracturing and weathering. The main units include limestone, shale and marl, but at BH-2 and 3, a dolerite unit is also encountered. Their

thickness is variable and generally it occurs in a cyclic fashion or sequence. At BH-2 dolerite extends to a depth of 7.4 m, below this depth a sedimentary sequence of shale and limestone are the dominant units.

Similarly at BH-3 trace of dolerite sill starts at a depth of 12.11 m and continues at a depths of 12.84, 13.95, 14.10 and 14.7 m. From these drill holes it is clear that limestone is the dominant rock unit and governing factor with respect to the hydraulic conductivity of the rock mass.

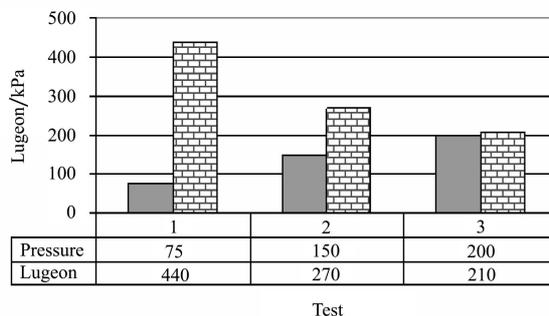
The test was conducted in three stages at different pressures. Calculation of the permeability of the rock mass shows in the order of  $10^{-3}$  cm/sec. A bar chart (Figure 17) showing the relationship of test pressure and Lugeon indicates a continuous reduction in Lugeon value

as test pressure increases. This condition is related to filling of void or fractures by finer materials during the course of testing.

Figure 17 Bar chart showing relationship of test pressure and Lugeon value

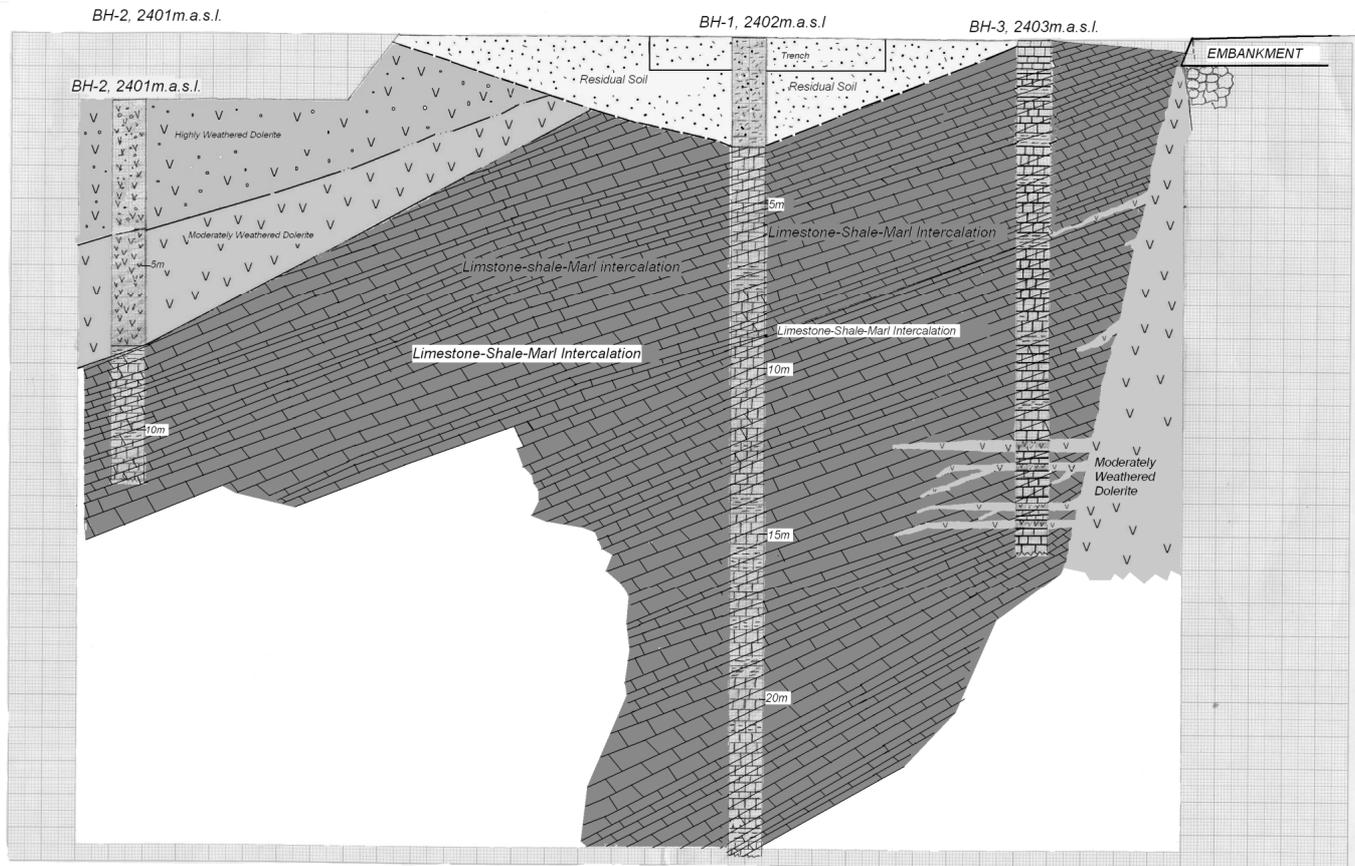
Synthesis of the different surface and subsurface information collected during the course of this research work leads to develop a comprehensive geological cross-section or model (Figure 18). The model helps to understand the leakage phenomena and assist in proposing and implementation of mitigation measures.

Figure 18 Engineering geological cross-section along the three boreholes (model)
