Presence and dimensional assessment of power take-off (PTO) protection of new Brazilian agricultural tractors

Abstract: Contact with tractor moving parts is one of the most frequent causes of accidents with agricultural machinery. Thus, the present study aims to verify the presence of power take-off (PTO) master shield and its dimensional specification, in new Brazilian agricultural tractors, according to ABNT NBR ISO 500-1 (2016) standard. We evaluated 43 agricultural wheeled tractors models, with power above 36.8 kW, distributed in seven dealers located in Santa Maria, RS. Data collection was based on the visual verification of the presence or absence of PTO master shield (BRASIL, 2013), as well as its dimensional variables verified through the use of measuring tape. Regarding the presence, 100% of the analyzed models contained the PTO master shield. Regarding the PTO master shield dimensions, tractor models classified as PTO type 2 or 3, fulfilled 100% of the current standard, however, considering PTO type 1, 79.31% showed total compliance. Regarding to the tractor manufacturers brands, four out of seven was totally non-compliant, two brands was non-compliant in most of the dim

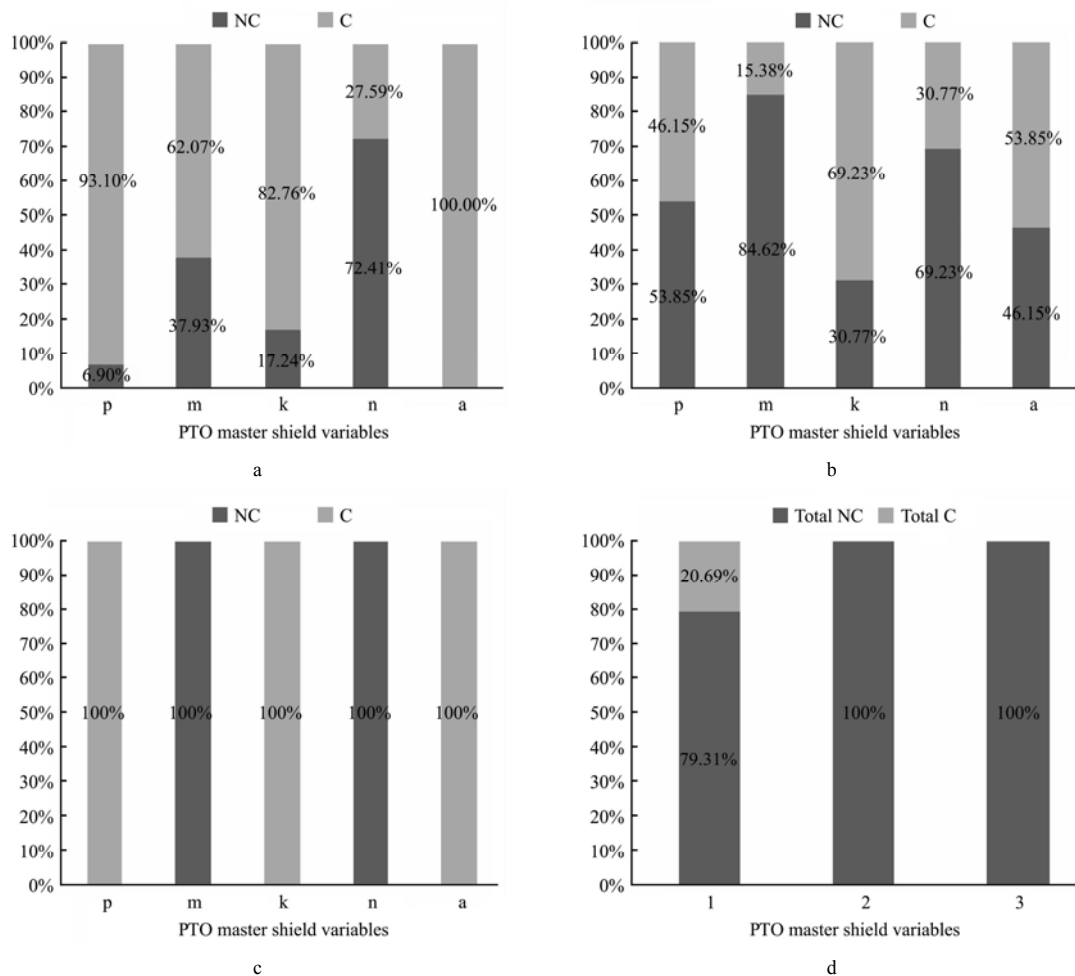
Figure 2 PTO master shield dimensions’ compliance level of PTO Type 1 (a), Type 2 (b), Type 3 (c), and total compliance level (d)

From the total of 43 models analyzed, 29 are in the range of Type 1 PTO, which corresponds to 67% of the sample. In relation to PTO Type 2 and Type 3, they corresponded to 1 and 13 models, characterizing 3% and 30% of the sample, in that order. Figure 2 shows the level of compliance of the protection dimensions, for each PTO Type.

The master shield dimension denominated 'a' showed complete compliance in the models evaluated with PTO Type 1 and 2, in addition to 53.85% of consonance in the models with PTO Type 3, standing out as the most consistent variable with the standard. While the dimensions 'm' and 'n' were, in general, the ones that presented lower levels of compliance, highlighting

negatively. Dimensions ‘a’ and ‘m’ refer to master shield frontal and lateral side, respectively, so the non-compliance may allow inadvertently access to the moving parts, contributing to accidents (Reis and

When analyzing the total compliance level (Figure 2d), comparing PTO Types, it can be observed that analyzed agricultural tractors models with PTO Type 2 or 3 did not fully meet the current standard. This result may have been influenced by the sample size, mainly in the PTO Type 2, which corresponds to 3% of the total models. However, tractors with up to 110 kW of power, classified as PTO Type 1, 79.31% showed total compliance with the ABNT NBR ISO 500-1 (2016) requirements.

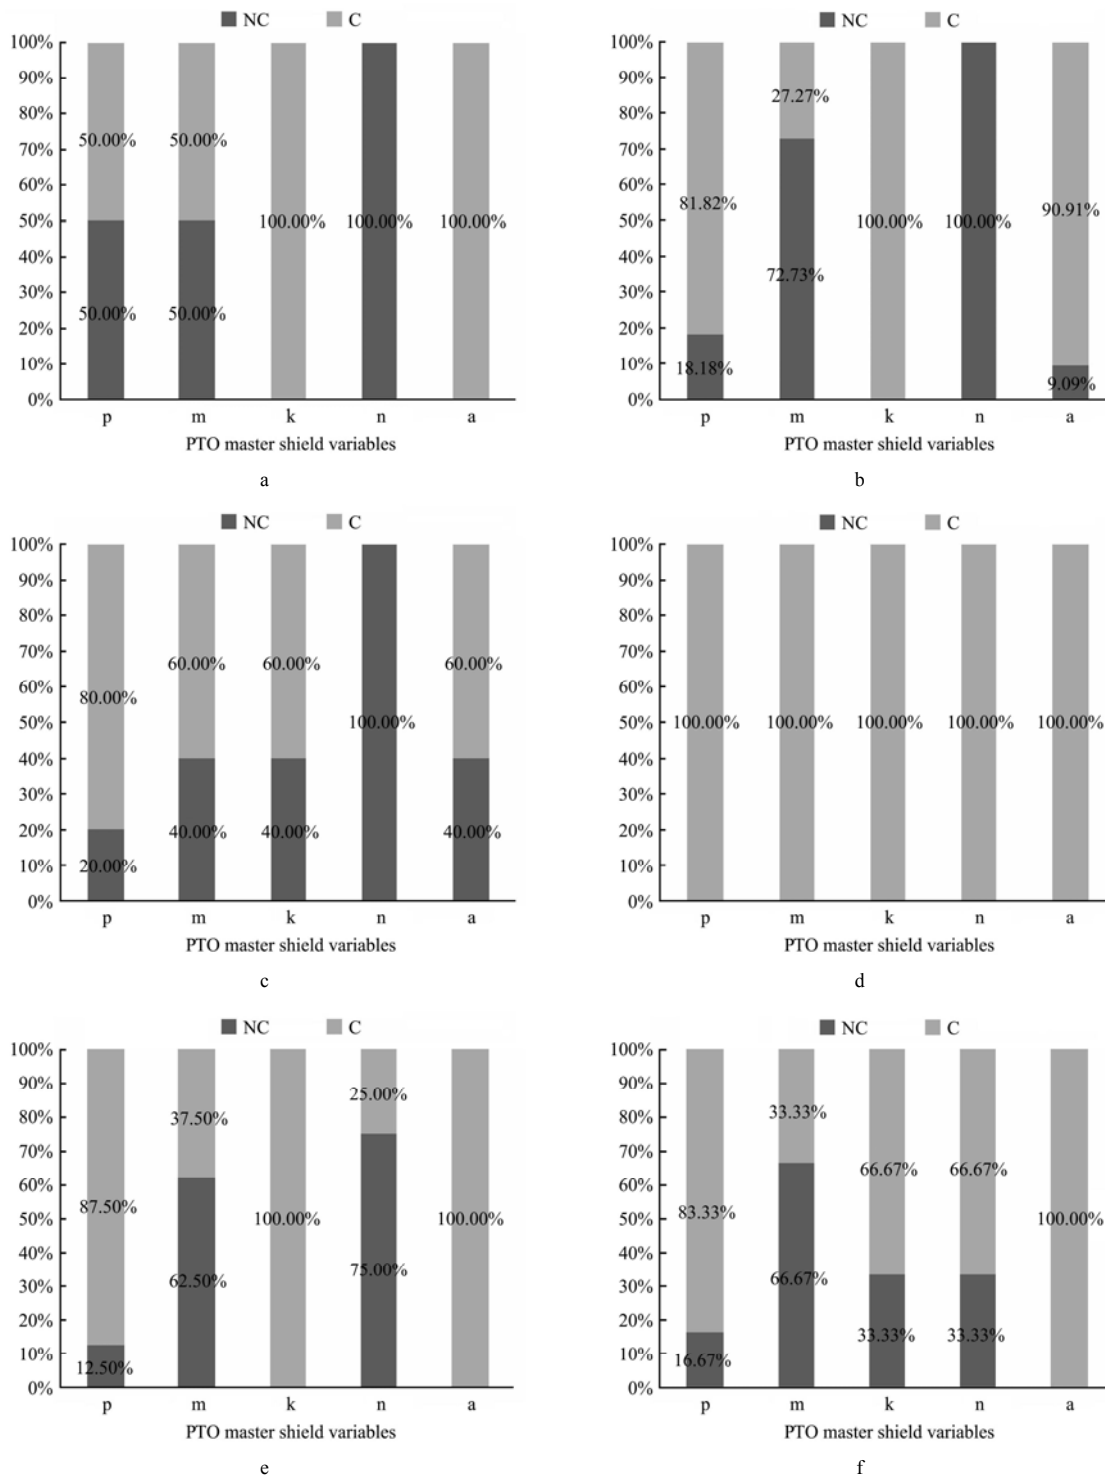
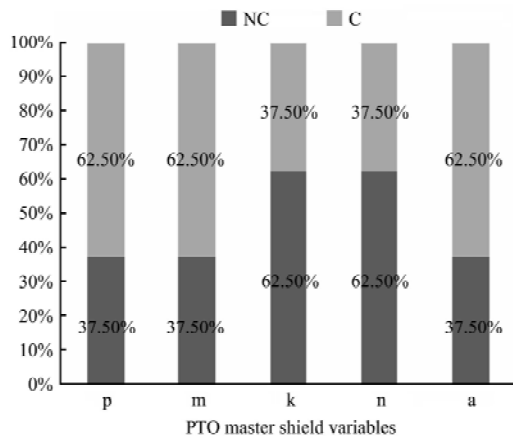
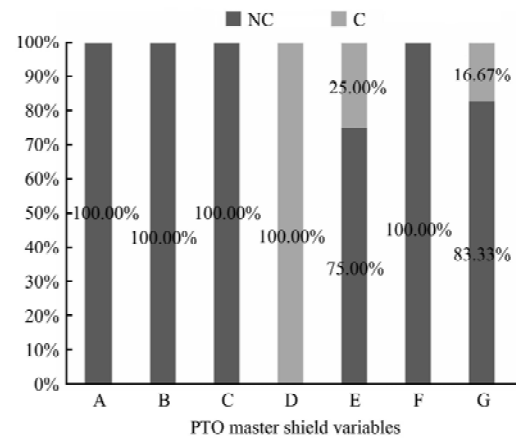
Figure 3 PTO master shield dimensions' compliance level by tractor brand - Brand A (a), B (b), C (c), D (d), E (e), F (f), G (g) and total compliance level (h)

Figure 3 shows the level of compliance of PTO master shield dimensions by tractor brand assessed (A – G) and the total compliance level (H).

The dimensions 'a', 'p' and 'k' presented a higher percentage of non-compliance in Brands B, C, D, E and G. On the other hand, the dimensions 'm' and 'n' presented less compliance in Brands A, B, C, D, E and F. The PTO master shield presence is of paramount importance, but its correct dimensions is of equal significance for preventing accidental contact with moving parts.

When analyzing Figure 3h, it was observed that four of seven brands covered showed total non-compliance (Brands A, B, C and F), two brands (E and G) presented non-compliance in most of the PTO master shield dimensions and only Brand D showed 100% compliance in all analyzed variables. This result indicates that there is no standardization by the Brazilian agricultural tractors manufacturers on the dimensional aspect of the PTO master shield.
