Development of a portable model of heat treatment tent with bottom black cover for the control of citrus greening disease in Brunei

Abstract: Citrus Greening Disease is a serious bacterial disease in citrus plants which causes loss of production of citrus fruits all over the world, including Brunei. A portable and thermal effective heat treatment tent was developed as an attempt to control and manage this disease. A 1.4 m tall tent with opaque canvas was fabricated to test for a 1.2 m tall lime tree. The testing involved heat treatment tests for three days with tent having black plastic sheet bottom cover and without bottom cover over the soil surface around the plant. Overall, the results proved that the plant was not damaged during the heat treatment, and the fabricated tent frame was light and portable with minor folding and stability problems. The tent was unable to maintain the desired temperature 38°C - 42°C for more than 5 hours due to the sun position and changing weather conditions, but the heat treatment test with tent having bottom black colour plastic sheet was able to maintain the temperature of the bottom part of the plant more effectively. Hence, the tent can be use

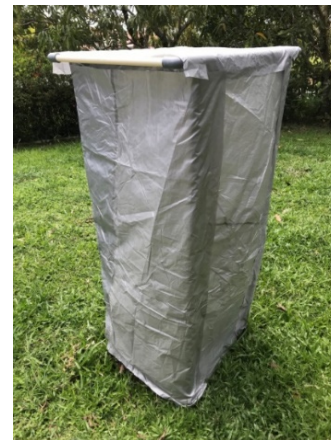
Figure 2 Final heat treatment tent

The protruding part of the frame could be detached to allow the tent to be folded and transported easily. PVC (Polyvinyl chloride) pipes were cut into six 0.6 m pipes and four 1.4 m pipes using a handsaw. The pipes were connected using the appropriate PVC fittings and further secured using the PVC glue. For the detachable joint, PTFE (Polytetrafluoroethylene) film tape was wrapped around the end of one PVC pipe to increase the thickness of the pipe to form tighter fitting connection. This was to allow detachment at one end and one plane rotation at the other end for folding purpose. Then, the canvas was cut into the required dimension to fit at the different sections of the tent. The canvas was secured to the frame using specialized glue and the final heat treatment tent is shown in Figure 2. Small gaps were intentionally made to allow flow of external air in order to avoid overheating of plant inside the tent. Small holes were also made at the top surface to allow rain water to enter the tent.

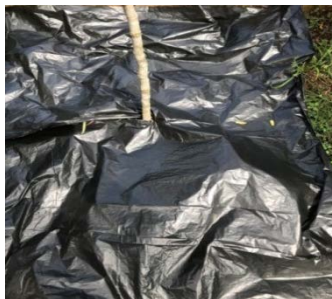
This experiment was similar to that of the previous experiment, but with the introduction of black polyethylene trash bag as shown in Figure 3, to act as a bottom cover of the tent to absorb heat for maintaining and sustaining uniform temperature at the bottom of the plant. The same data collection and examination procedures were performed.

Figure 3 Bottom part of the plant covered by black polyethylene bag

The bottom temperature of the tent was also consistent with the top temperature and occasionally, was higher than the top temperature. This indicates that the black cover at the bottom of the tent helped to absorb the heat during peak temperature and distributed the heat inside the tent effectively. The ambient temperature was affected by the intensity of heat from the sun and the position of the sun as

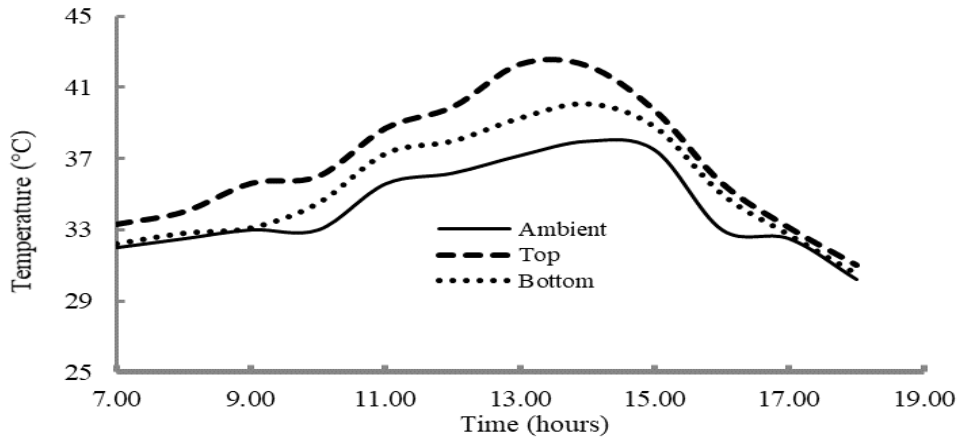
Figure 5 Graph for the heat treatment results without bottom cover for day 2, April, 24, 2018

From analysis of the temperature profiles against time (Figures 4-6), the desired temperature which were fatal for Las Bacteria, were reached between 11:00 – 16:00 hours at the Brunei environmental conditions. This time range occurred when sun was in the right position to heat the tent for the treatment process. This indicates that the tent was capable of performing its function for five hours only during the day. The temperature inside the tent were higher than the ambient temperature due to the accumulated heat trapped inside the tent which caused the interior temperature to rise higher. The temperature at top part of the tent was higher as the sunlight directly hit the top part first before the heat was distributed towards the bottom. Hence, the temperature at the bottom was slightly lower. Figures 4-6 display the graphs for the heat treatment test without bottom cover. The temperature at the top of the tent were observed to be consistently higher than the bottom temperature throughout the heat treatment, while the temperature at the bottom of the tent remained between the top temperature and ambient temperature lines. It is clear from the figures 4-6 that the temperature inside the tent can be easily raised to the desired temperature 38-42 °C, particularly during 11:00 to 16:00 hours. The ambient temperature directly affected the temperature inside the tent as observed from the graph. This is due to the temperature inside adapting to the temperature changes in the surrounding faster due to the lack of insulation between the interior of the tent and the environment.

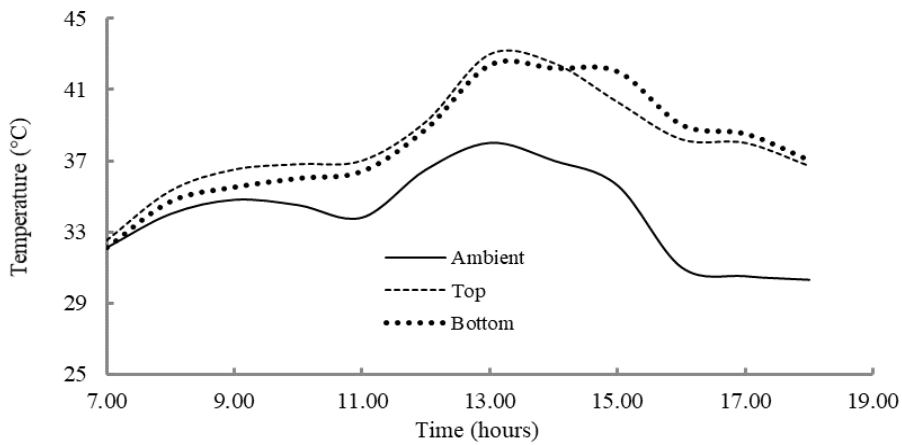
Figure 9 Graph for the heat treatment results with bottom cover for day 3, April 28, 2018

Figures 7-9 display the graphs for the heat treatment test with bottom black plastic cover. The temperature patterns were almost similar to that of the other test, but a few significances were observed at the temperature lines

from 12:00 hour onwards. The temperature inside the tent was maintained at high temperature despite the dropping ambient temperatures at a large offset.

The three days average ambient temperature with bottom covered with black plastic sheet during 11:00 AM 17:00 PM was 35°C and the tent inside temperature was 40.5°C (Figures 7-9). It indicated that the tent was able to maintain above 40.0°C each day for more than 5 hours. It is also proved that if the tent is used continuously for 7-8 days it could drastically reduce a reduction in the level of HLB bacteria as found in earlier research (O'Brien and Duan, 2013). Based on the results (O'Brien and Duan, 2013) exposing the seedlings to 40°C -42°C for a minimum of 48 hours within a week could eliminated or significantly reduced the HLB bacteria in the treated citrus seedlings. The treatment involves placing an infected plant under an enclosed space, where the temperature inside are raised to a high temperature using solar energy in order to eliminate the existing pathogens and to slow down the spread of disease inside the plant (O'Brien and Duan, 2013).
