Evaluation of Wooden Silo during Storage of Maize (*Zea mays*) in Humid Tropical Climate

B. A. Alabadan

Department of Agricultural Engineering,
Federal University of Technology, Minna. Nigeria.

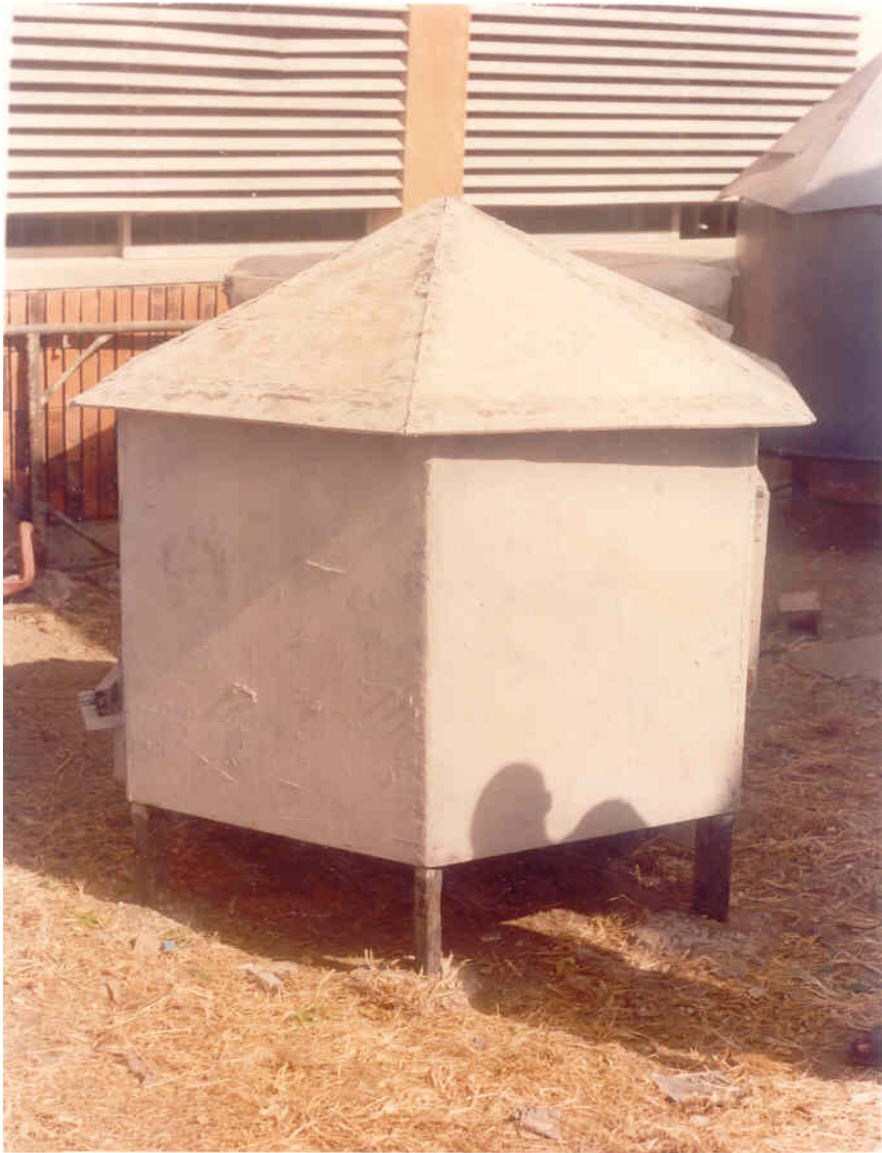
Photo 1: Installed Hexagonal Wooden Silo

The wooden silo is hexagonal in shape having internal dimensions of 1.1m in height and 1.4m in diameter (Photo 1). Plywood of exterior grade was used. The plywood is 3 plies (9 mm) thick, 1440 mm by 2880 mm in area and bonded together using Phenol – formaldehyde resin adhesive. The plywood was used for the walls, roof and floor while a 2 by 2-solid Iroko (*Melicia excelsa*) timber was used for the frames. The silo has three openings; a triangular shaped one at the top for loading, and two rectangular shaped ones at the sides that serve as door and discharge chute. The door was used for loading until the lower door level is reached with stored grains while the remaining was loaded through the roof opening with the door and discharge chute closed. The discharge chute is used for unloading. All the openings are normally kept closed so that the bin is practically airtight.

The silo is one-third capacity filled with shelled corn of 300 Kg weight at initial moisture content of 13.8 % wet basis. The silo is raised 0.5m above the ground level with the timber columns. The columns were erected in six dug earth holes filled with a 1: 2: 4 concrete mix to the ground level. All the surfaces of the bin were under almost similar ambient conditions.

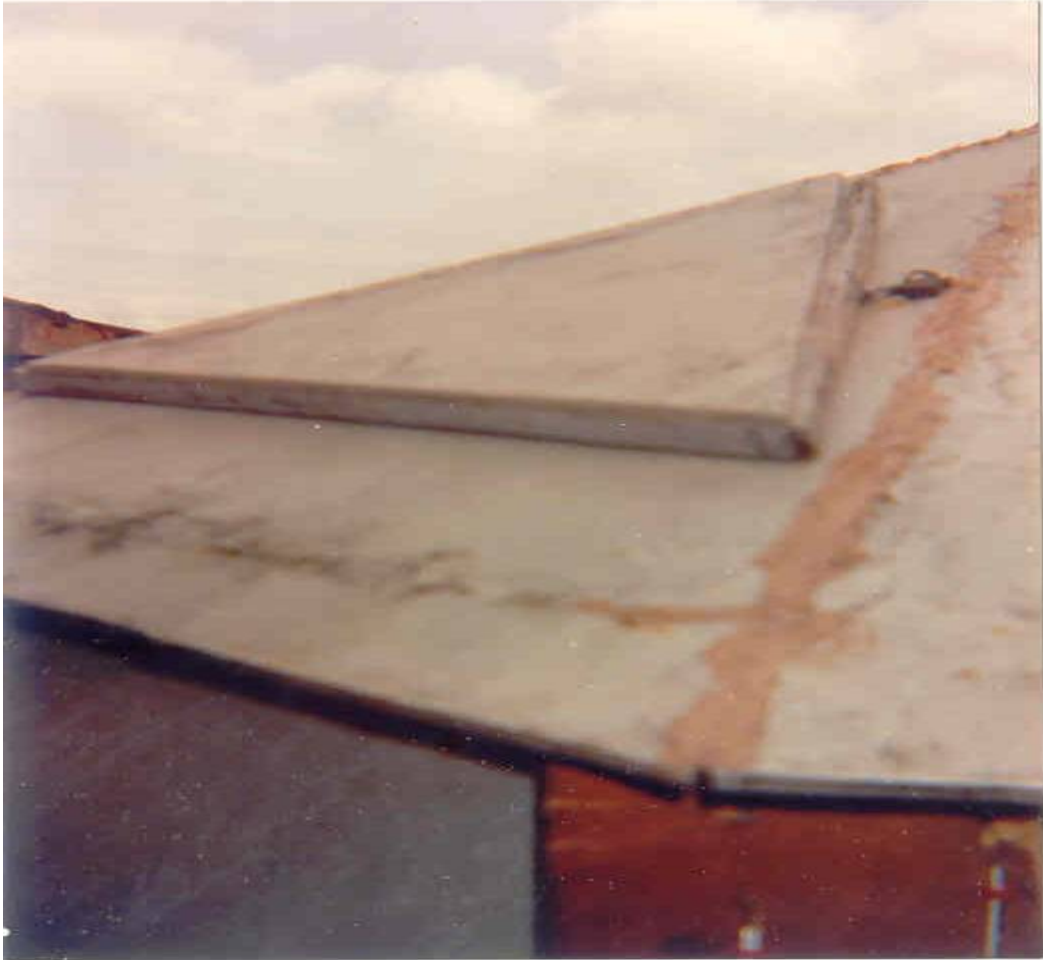
Photo 2: Delaminating of Joints

The six wall panels were jointed together with nails and the remaining crevices filled with car body filler to ensure an airtight silo system. The joints were constantly observed for any sign of failure such as nail pulling or opening of the inter-panel spaces. No sign of any failure was observed from installation until around February 1999, which is after 12 months of installations when small openings were noticed at roof panels as shown in Photo 2. These were filled with body filler as shown in Photo 2. This may be attributed to the effect of weather and the nails that are losing their gripping powers due to the alternating wetting and drying of the wood product. No warping was observed.

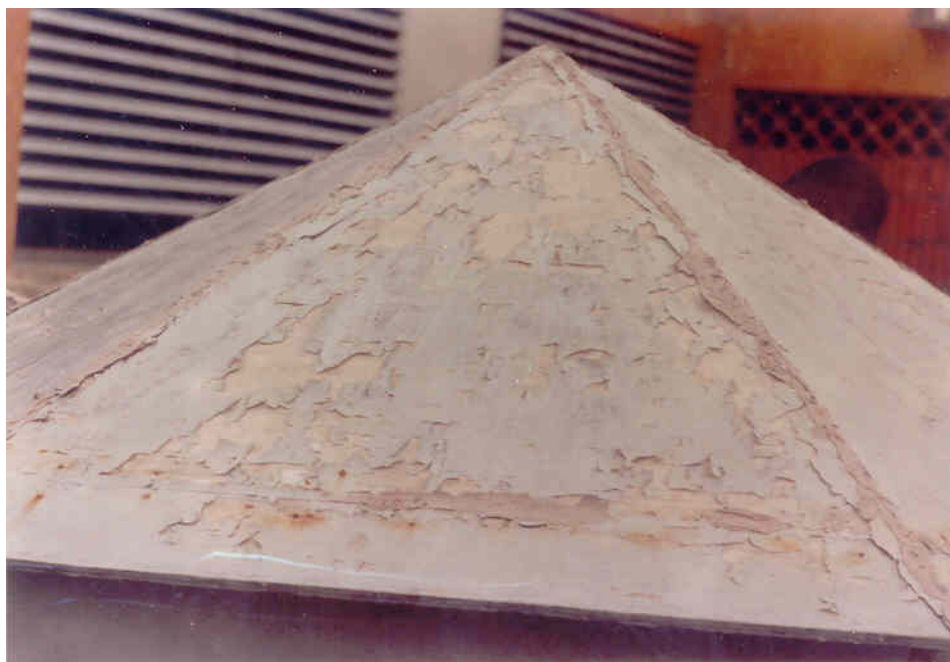
Photo 3: Mild Peeling of Sheathing Material

After the wet season of 1998 in October, the silo was exposed to a dry season from November 1998 to April 1999. Photos 3 and 4 showed stages of delaminating and peeling developments. Initially, it was the joints that were delaminating but due to continued exposure to weather over a period of time, the sheathing material for the silo roof began to peel. Photo 4 shows severe peeling of the painting materials and a thin ply layer of the plywood. The peeling is more pronounced where four roof panel members met and also at other parts of the roof. However, there were no traces of peelings on the wall panels. Continued peelings reduce the plies of the plywood and hence constitute a weak part of the material and structure. The peeled parts would allow free entrance to water, insects and other deteriorating agents. Provision of shade over the storage structure would help to reduce or eliminate the problem.

The defects such as colour change, delaminating and peeling of sheathing materials noticed can be eliminate, minimized or reduced by insulating or covering the silo structure with a shade.

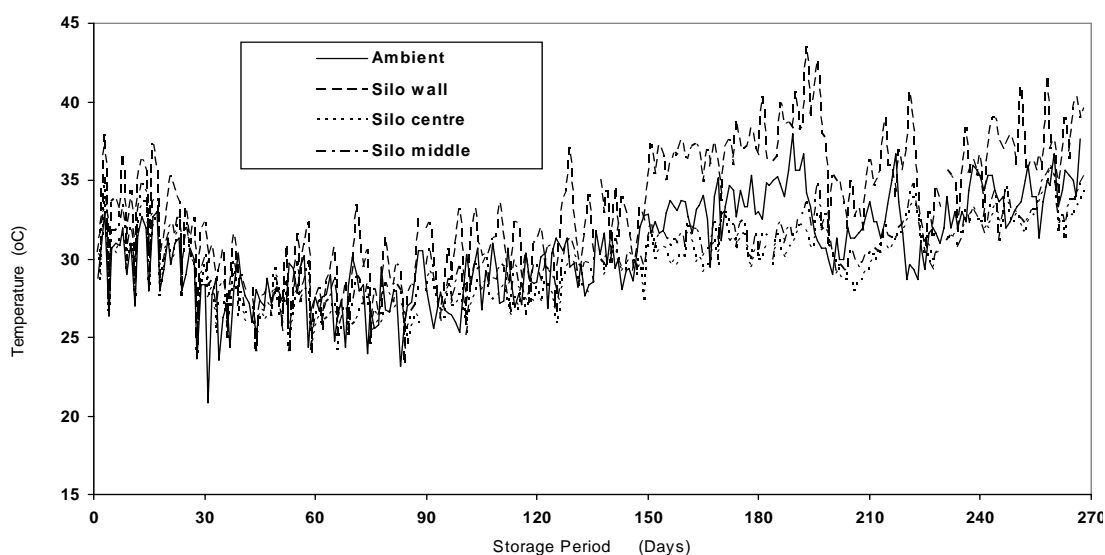
Fig. 1: Ambient and Measured Temperatures at the Geometric Centre, Middle and wall of the Wooden Silos.

Minna is located in the Middle Belt Zone of Nigeria. The dry season lasts between November and March with the on-set of rain usually around April. The average monthly temperature ranges between 28.5°C around the wet season of August to 38.9°C in the dry season of February and March giving a range of 10.4°C (FAAN, 1999). The corresponding average monthly rainfall is usually about 409 mm in August and none in February and March. Figure 1 shows the temperature variations within and outside the wooden silo.

The ambient temperatures were lower than the wall temperatures but higher than the middle and centre temperatures. Temperatures decreases from the wall to the centre. The wooden silo was able to keep down temperature fluctuations within the silo interiors and hence will

perform better in the tropics than steel (Alabadan and Oyewo, 2005). There were no incidences of moisture condensation within the silo even with the higher wall temperatures.
