Performance evaluation of irrigation schemes: a case study of Akumadan and Kaniago schemes in the transition agro-ecological zone of Ghana

Abstract: This work assessed the performance of the Akumadan and Kaniago irrigation schemes in the transition agro-ecological zone of Ghana using a set of comparative performance indicators. The performance of the schemes spanning the years 2018 – 2022 was evaluated using selected comparative indicators categorized into five (5) groups, namely: water delivery, physical structures, financial, environmental condition and agricultural production performance. The challenges of the schemes were also identified through the study. It was revealed that the main pipe at Akumadan had 100% maximum flow length while the canal system at Kaniago recorded a flow length of 64% due to low gravity-flow in the downstream of the canal. The developed irrigable areas in Akumadan and Kaniago were under-utilised with irrigation rates ranging from 15% – 36% and 18% – 57% respectively. The sustainability indices of the irrigated areas in Akumadan and Kaniago were low with recorded values of 31% and 28% respectively. Irrigation service charges recovery was poor in the Ka

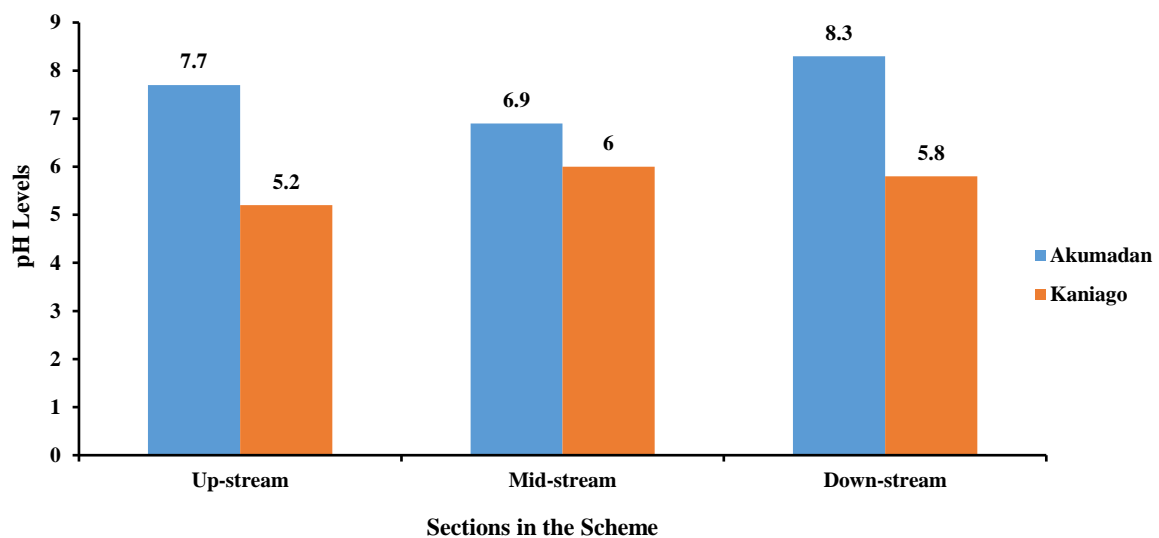
Figure 2 Soil pH levels of irrigable areas

As shown in Figure 2, the Kaniago scheme recorded average soil pH of 5.7 depicting moderately acidic soils. Soils from Akumadan scheme recorded average pH value of 7.6 indicating slightly alkaline soils in the irrigable area of the scheme. The T-test analysis performed on soil pH values obtained for the upstream, midstream and downstream of the irrigable areas in the schemes gave p-value of 0.010697 (< 0.05). This indicates that the differences in soil pH at the various sections of the irrigable areas of the schemes was statistically significant. The slightly alkaline nature of the Akumadan scheme soils could be attributed to naturally occurring sodium carbonate

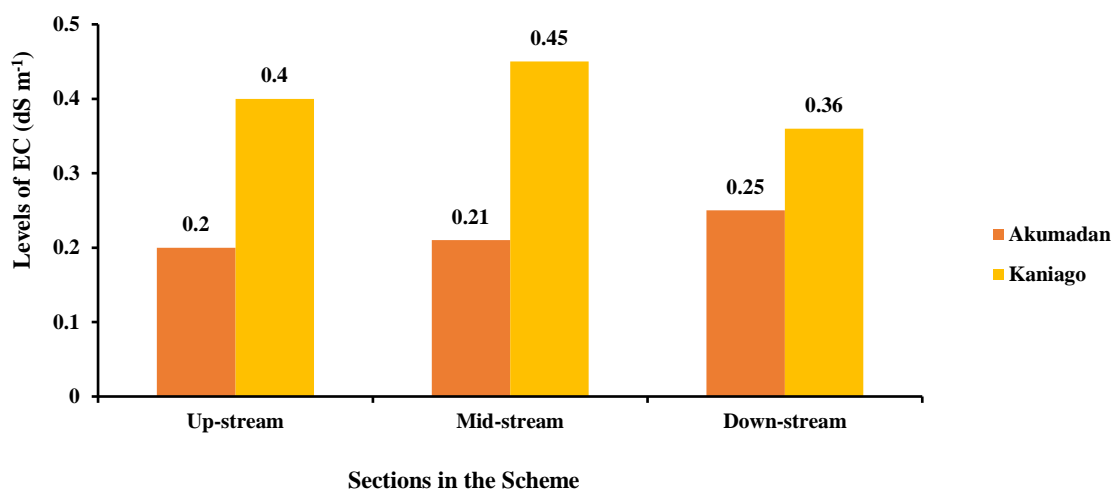
Figure 3 Salinity levels in soils of the irrigable areas

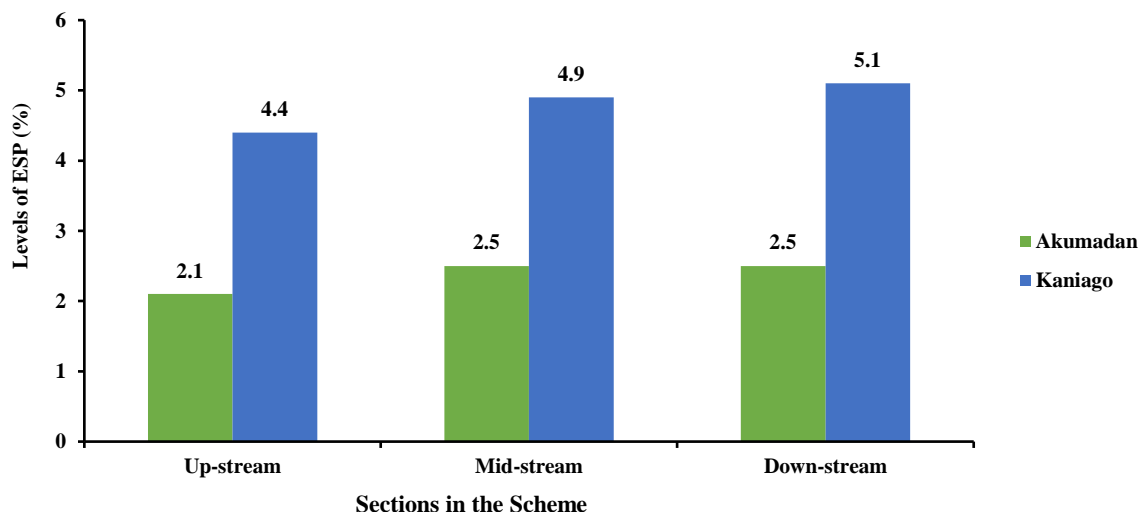
The ESP indicator was used to determine the sodicity levels in soils found in the irrigable areas of the schemes. The measured ESP values are presented in Figure 4.

Figure 4 Levels of sodicity in the soils of the irrigation schemes

The average ESP values recorded at Akumadan (2.4%) and Kaniago (4.8%) showed differences in proportions of sodium in soils of the irrigable areas of the schemes. The *p*-value of 0.00641 (< 0.05) from *T*-test analysis shows a significant difference in sodium

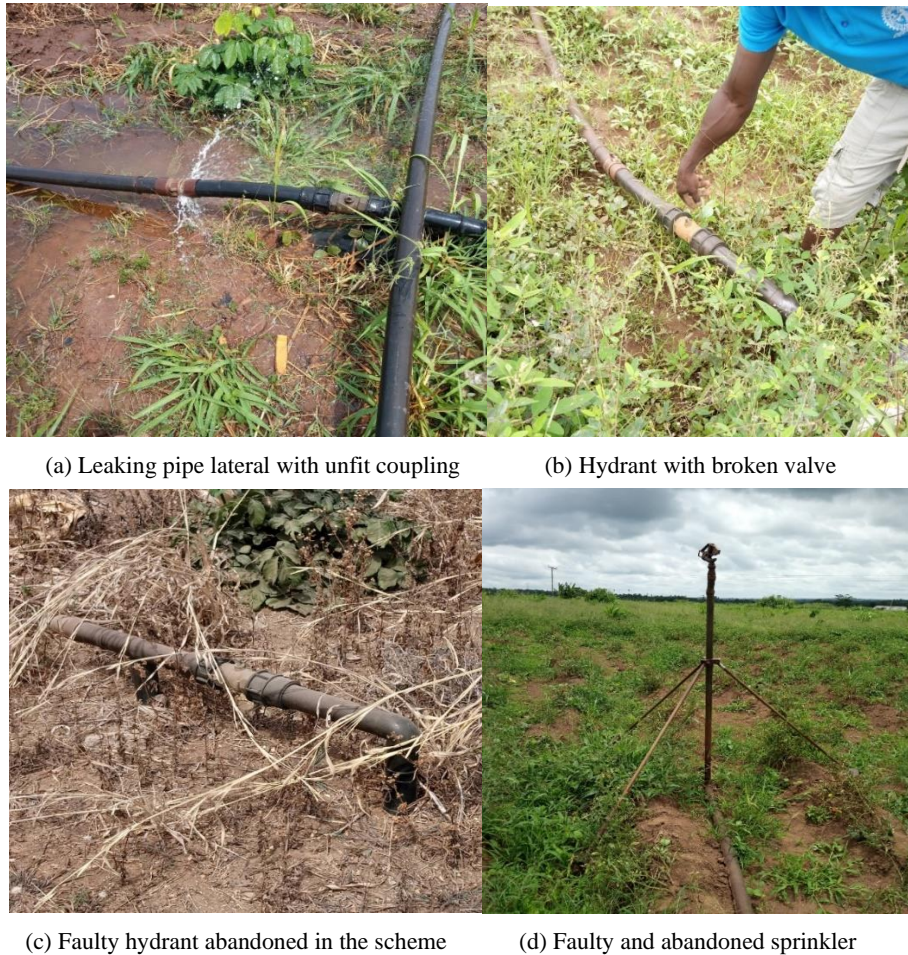
Akumadan irrigation scheme: The Table 5 shows PSI of 27% recorded on the scheme. This means that 73% of the conveyance, regulatory, flow measurement and energy utilization structures were in good working condition. A survey on the scheme revealed the poor physical condition of many sprinklers and hydrants. Moreover, laterals with unfit couplings made connections difficult on the scheme.

Regarding the condition of infrastructure, the Akumadan scheme was confronted with challenges of many faulty sprinkler heads, inadequate laterals with un-fit coupling and hydrants having broken valves.

These challenges affected conveyance and uniform distribution of water on the scheme. At Kaniago, the infrastructure challenges were that of faulty hydrants and poorly designed canal slope that resulted in low gravity flow in the main canal hence affecting water

conveyance to the downstream of the scheme. Shown in Figures 5 and 6 are photographs of poorly functioning infrastructure in the Akumadan and Kaniago schemes.

Figure 5 The deplorable state of structures in the Akumadan scheme

Management should ensure regular and periodic repairs, maintenance and replacement of infrastructure in the schemes.

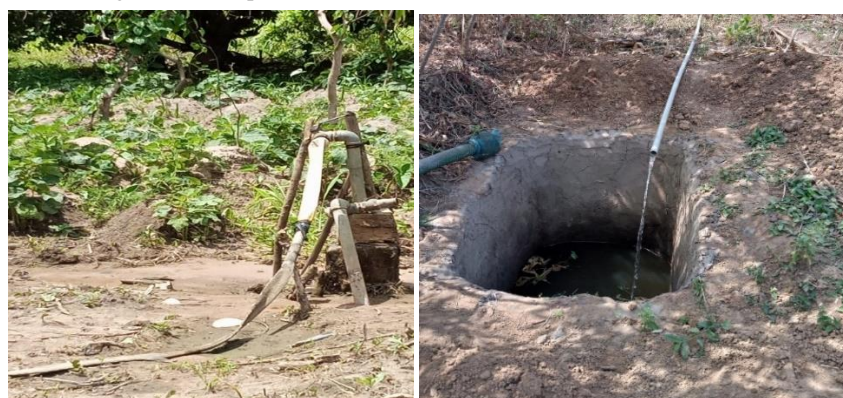
Kaniago irrigation scheme: The scheme recorded a low PSI of 14%. Consequently, 86% of structures on the scheme were in good working condition. The canal, canal valves, gate structures, weir and flume remained in good operating condition except for the faulty and nearing fault hydrants on the scheme. In all, the condition of structures on the scheme was commendable.

Figure 6 The challenges in the Kaniago scheme

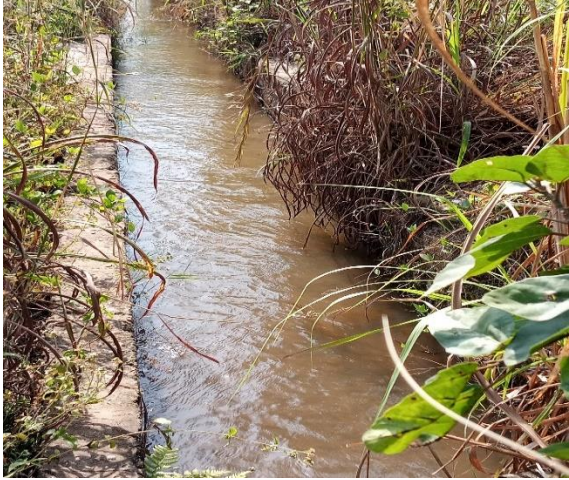
Canal

The main canal at Kaniago was in good condition with no damaged walls and leakages. However due to very low velocity flow at the downstream of the canal, the flow length was reduced by 36%, equating to 0.8 km of the total canal length (2.2 km). Ijir (1994) indicated a notional normal value of 100% for extent of main canal/pipe flow lengths.
