Geological, geophysical and engineering geological investigation of a leaky Micro-dam in the Northern Ethiopia

Gebremedhin Berhane

ABSTRACT

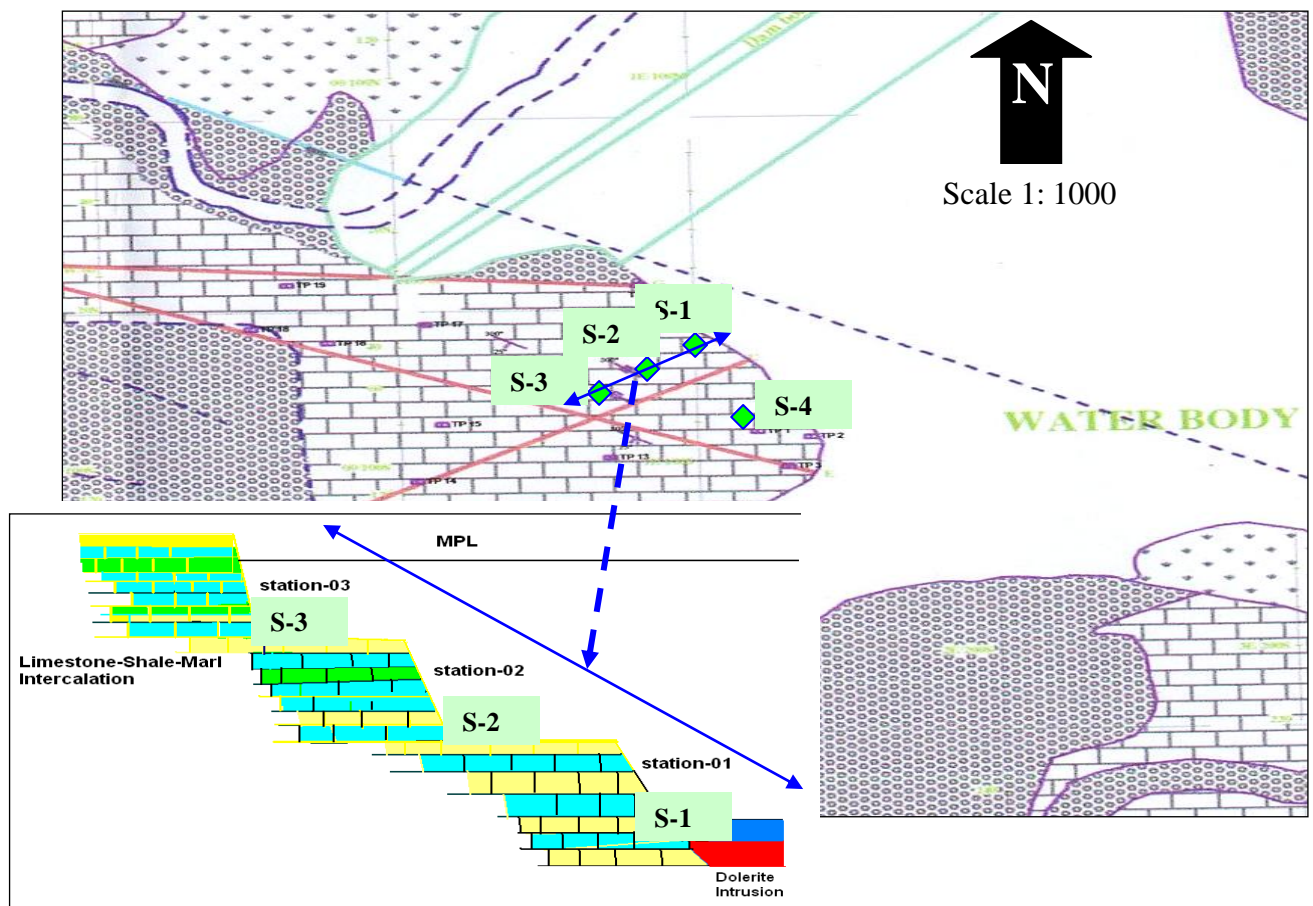
Figure 5. Simplified location of map of station points for discontinuity measurement

Joints in outcrops of the abutment slope were studied. Figure 5 shows location of some of measurement stations and Table 1 presents the joint parameters measured in the field. Considerable amount of data was collected from the site, measurements were taken systematically to avoid biasness and emphasis was given to joints with favorable orientation to leakage with respect to alignment of the dam axis and reservoir configuration. Discontinuity sets were identified visually. Accessible surfaces were measured, which may be representative for the joint survey.

The frequency or spacing of joints on average ranges from 30 to 45 per meter, i.e. closely to very closely spaced. The joints are generally continuous laterally and in depth.

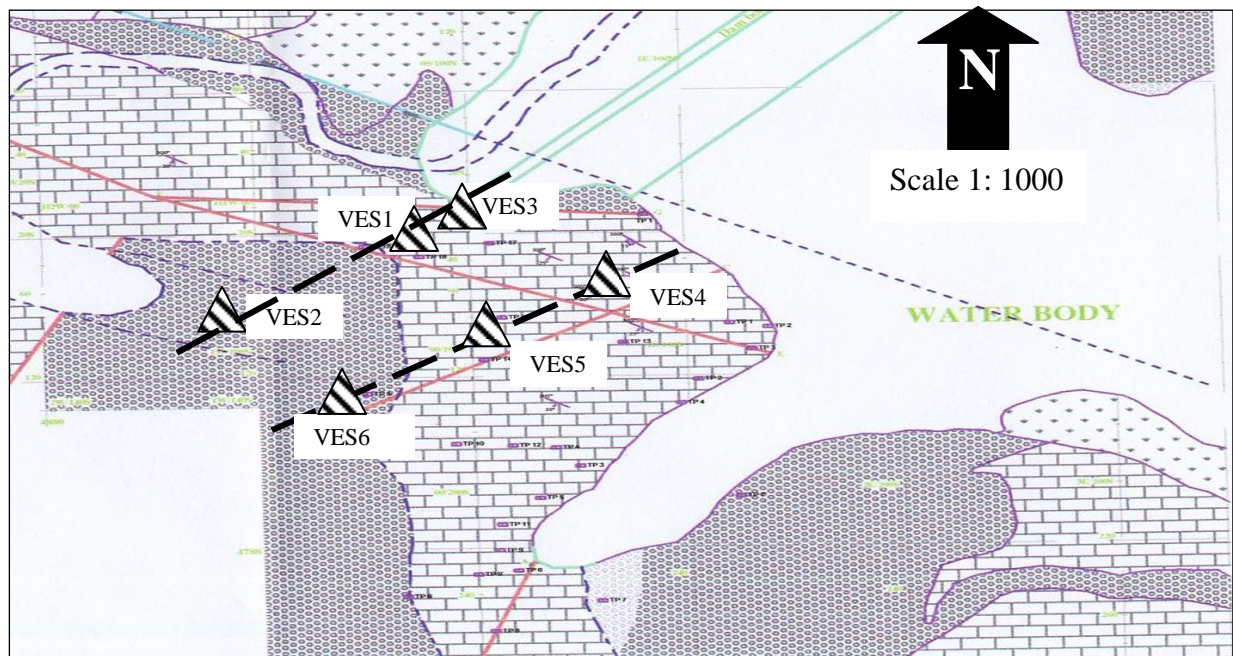
Figure 9. Location of vertical electrical sounding (VES) points

On the three VES points, out of six, shallow geotechnical drilling was conducted and the results of VES are interpreted based on the information from borehole (Fig. 9)

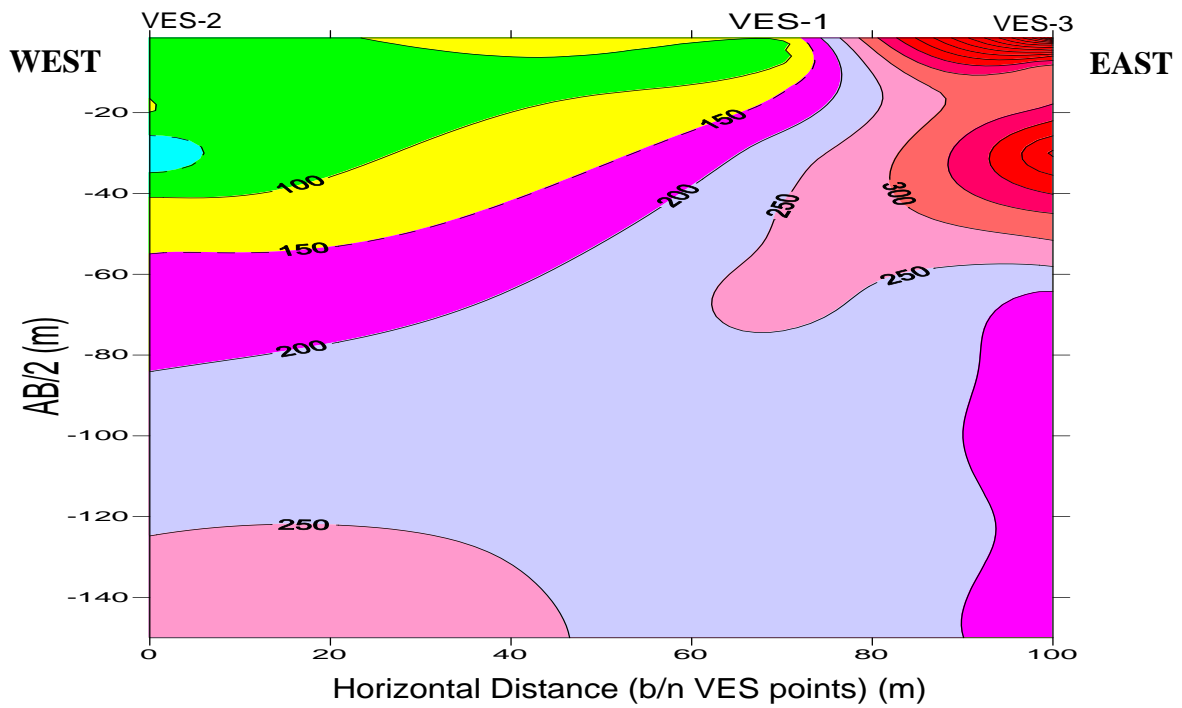
Figure 10. Apparent resistivity pseudosection (Ohm-meters) along VES2, VES1 and VES3.

The resistivity values show an interesting variation in depth and to some extent in space. The variation in depth shows difference in lithology and moisture content. The upper top most part shows higher resistivity value indicating its drier condition. The pattern of the electric sections (Figs. 10 to 12) also signifies inclination of the sedimentary beds. The inclination has important geotechnical implication.
