# Geological, geophysical and engineering geological investigation of a leaky micro-dam in the Northern Ethiopia

Gebremedhin Berhane

**Abstract:** The study was conducted to assess the main causes of leakage problem in the Hashenge micro-dam, located in the Tigray regional state, northern part of Ethiopia. The micro, dam is a 19 m height earth fill dam with the length of 387 m and reservoir capacity of about 2.3 million cubic meters at maximum water level. Geological, geophysical and engineering geological investigations were conducted in the abutment and reservoir area to assess and pinpoint the main causes. The dominant lithologic units include limestone-shale-marl intercalation, dolerite and recent soil deposits. Vertical electrical sounding was used to locate geotechnical boreholes and to know vertical and lateral variability of geological materials. Geotechnical and engineering geological investigation including drilling of three boreholes and packer testing along with detail measurement and analysis of discontinuity parameters was conducted. Analysis of the data showed that the sedimentary succession, limestone-shale-marl intercalation was the leaky unit and responsible to

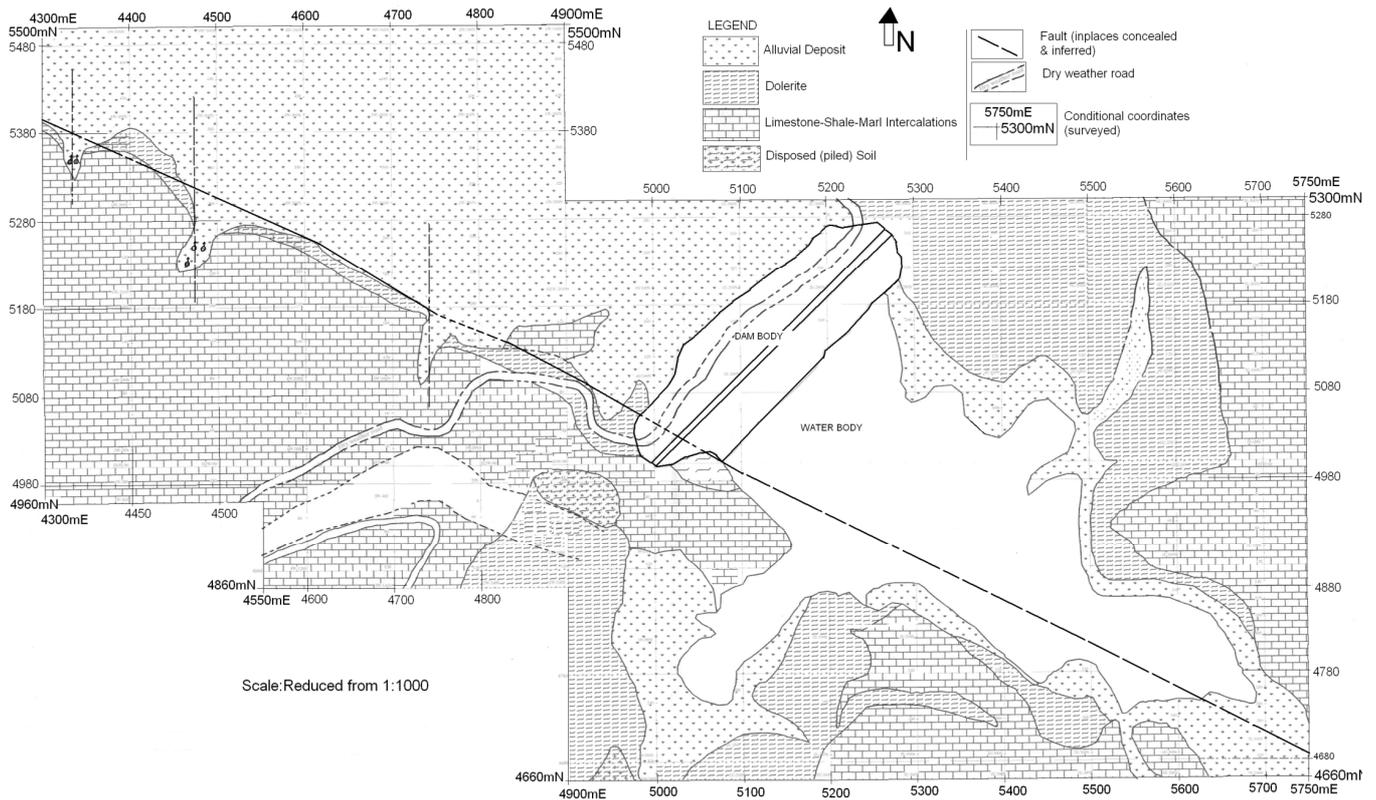
Figure 3 Geological map of Hashenge dam site and its reservoir area

The major lithologic units found in the Hashenge area are the limestone-shale-marl intercalations, dolerite and alluvial deposits. Figure 3 shows simplified geological map of the dam site and reservoir area.

Alluvial deposit is found mainly on the command area or downstream of the dam and along the reservoir floor. Its thickness is generally variable, but thicker near the river course and becomes thinner toward the steep sides of abutments and reservoir periphery. Clay/silt is the dominant size that constitutes the deposit.

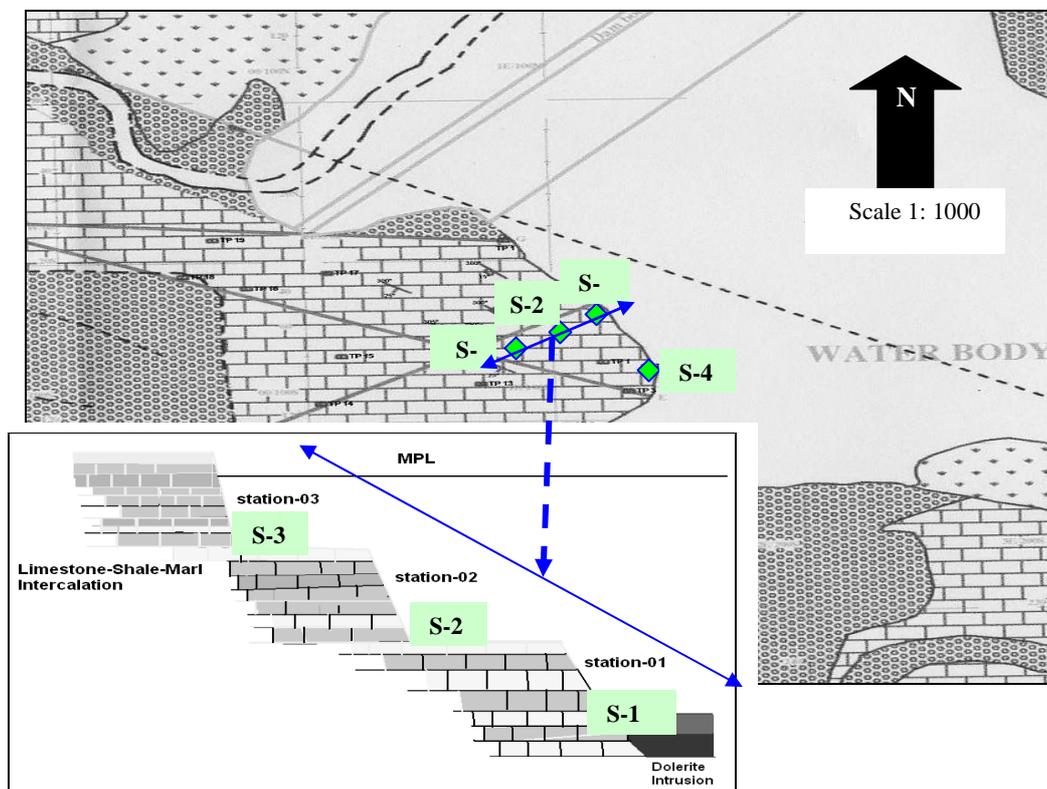
Figure 5 Simplified location of map of station points for discontinuity measurement

Joints in outcrops of the abutment slope were studied. Figure 5 shows location of some measurement stations and Table 1 presents the joint parameters measured in the field. Considerable amount of data was collected from the site, measurements were taken systematically to avoid biasness and emphasis was given to joints with favorable orientation to leakage with respect to alignment of the dam axis and reservoir configuration. Discontinuity sets were identified visually. Accessible surfaces were measured, which may be representative for the joint survey.

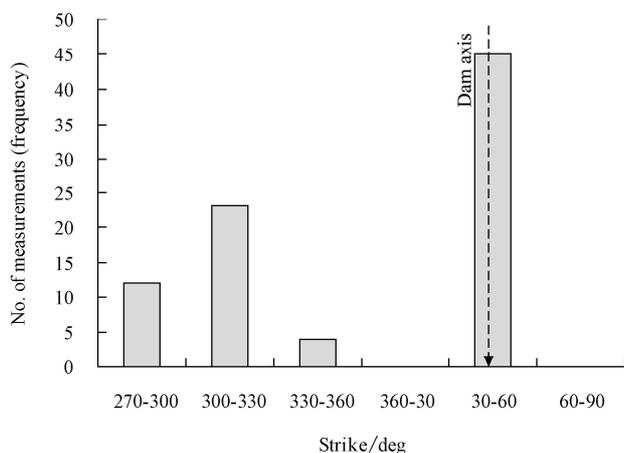
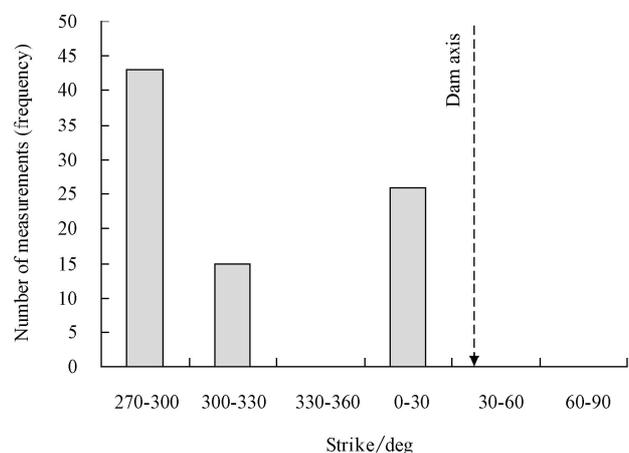
Figure 6 Histogram of discontinuities (left abutment)

Figure 6 and 7 show histogram of discontinuities taken on the left abutment (Table 1). Leakage of water through rock masses usually takes place via the discontinuities, although in some sedimentary rocks leakage through the pores may also play an important role. The joint parameters measurement in the field include joint spacing, opening/aperture, strike and dip, infill material type and amount, continuity and number of joints at the station or exposure extent.

The frequency or spacing of joints (Figure 8) on average ranges from 30 to 45 per meter, i.e. closely to very closely spaced. The joints are generally continuous laterally and in depth surface of joints (wall surface) is smooth with some calcite precipitation. The space between joint surfaces (separation/aperture) is variable from place to place (narrow to wide aperture); many of the measurements show in the order of millimeter to few centimeter.

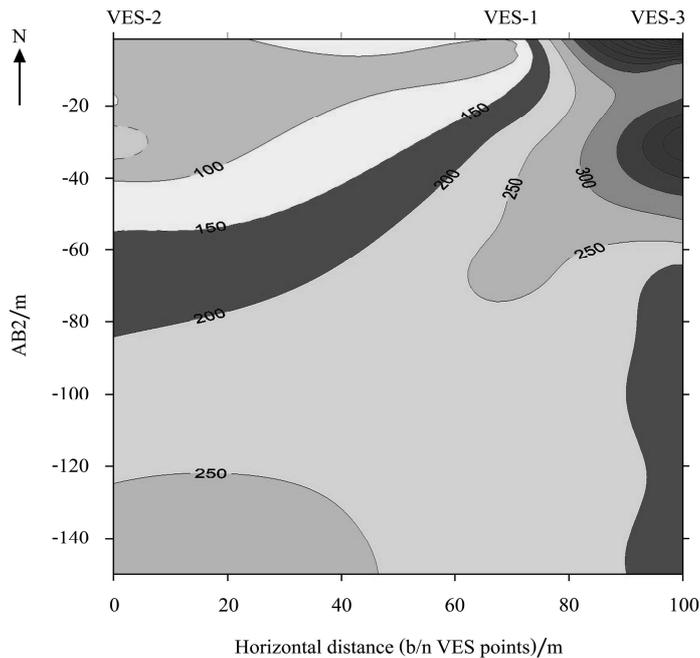
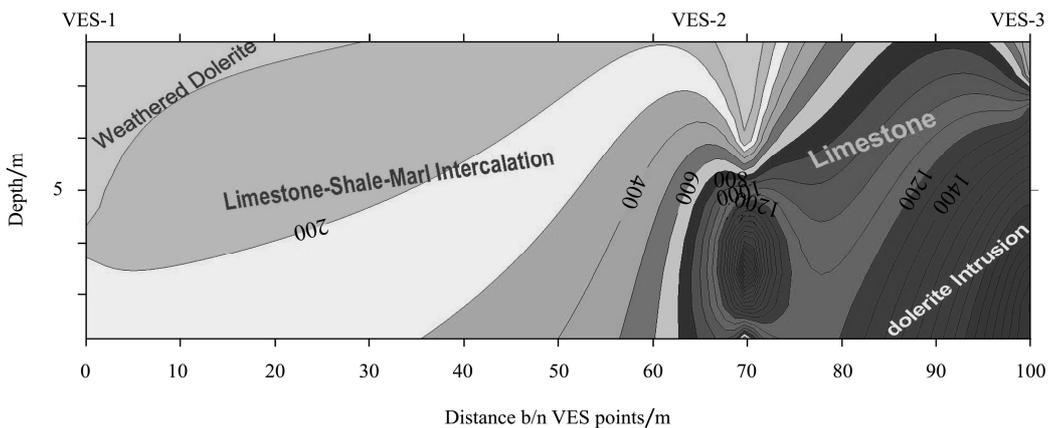
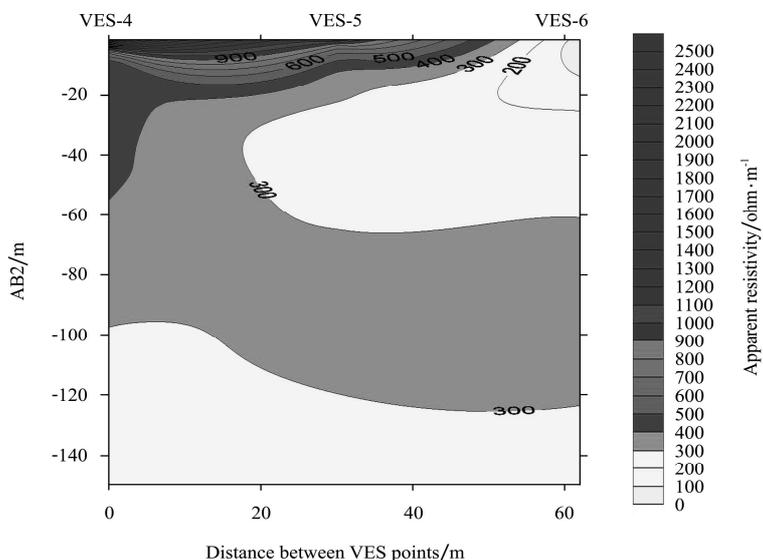
The resistivity values show an interesting variation in depth and to some extent in space. The variation in depth shows difference in lithology and moisture content. The upper top most part shows higher resistivity value indicating its drier condition. The pattern of the electric sections (Figure 10 to 12) also signifies inclination of the sedimentary beds. The inclination has important geotechnical implication.

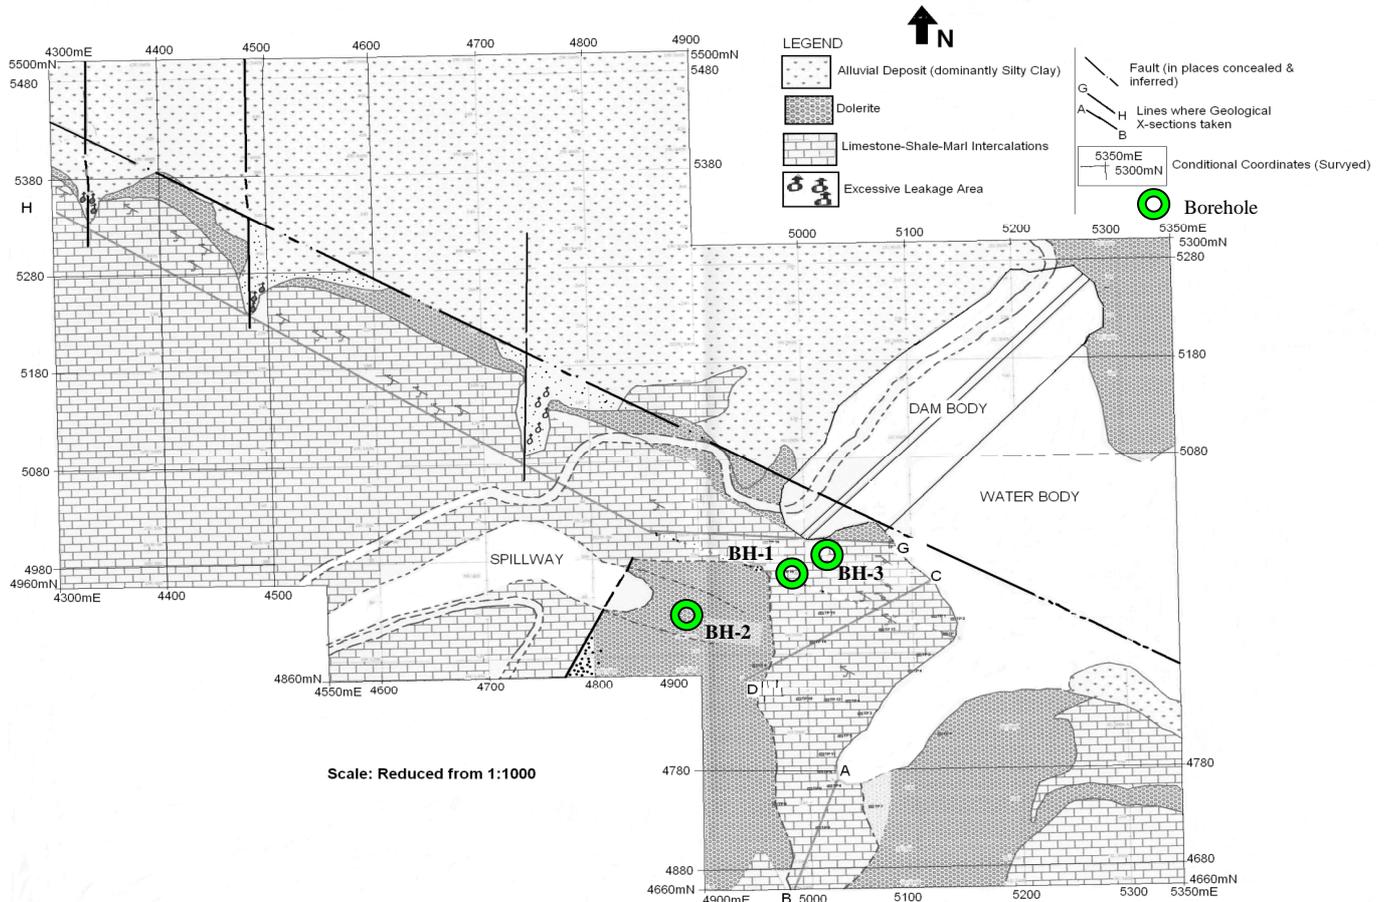
Figure 13 Detail engineering geological map of Hashenge dam site and its reservoir

As per the pervious studies the dam foundation and abutments is composed of dolerite and the cut-off is extended to fresh dolerite. This unit covers most part of the reservoir area and extends to south side up to the rim of the reservoir (Figure 13). Concordant and discordant igneous bodies are observed in the area which indicates a dyke and sill pattern. These emplacement mode or nature of intrusive igneous rocks has engineering significance. Massive intrusive bodies such as stocks and batholiths tend to have relatively homogeneous compositions and textures that are three-dimensional throughout. Tabular intrusive bodies such as dykes and sills create more construction or rock-utilization and water harvesting problems than massive intrusives because of the inherent lack of the three-dimensional continuity that is found in massive intrusives.

All the above engineering geological features lead to signify that this unit is relatively impermeable, i.e. due to homogeneity of the dolerite and absence of closely spaced and open joints (Figure 13). The upper top part of the unit is affected by weathering and hence pervious.

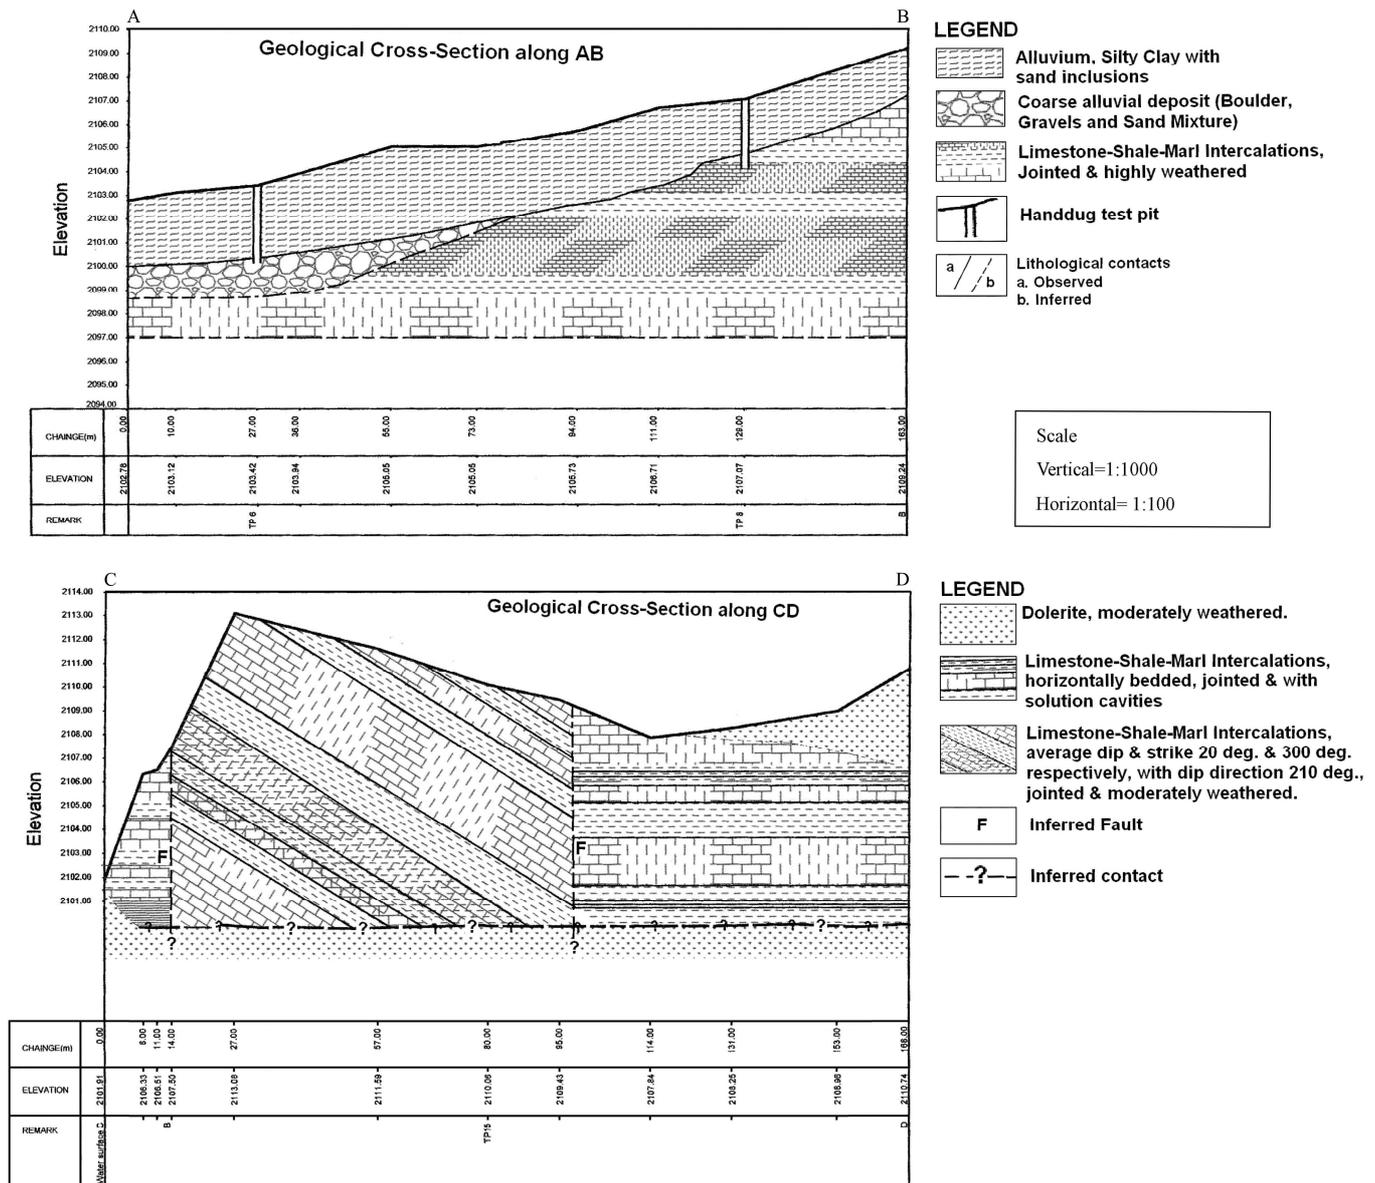
Figure 15 Engineering geological cross-section along AB and CD

Figure 14 and 15 show cross-sections along selected lines to portray the subsurface condition.
